FUSELAGE REPAIR

**STRUCTURAL SUBSTANTIATION
CESSNA 421 FUSELAGE REPAIR**

**REPORT NO. : GTA-0462-01
MODEL NO. : 421C
SERIAL NO. : 421C-1213**

HORIZONTAL STABILIZER TRAILING EDGE REPAIR DESIGN AND INSTALLATION
 (FOR ONE AIRCRAFT ONLY - A CESSNA 421C, S/N 421C1213, T/N N421SM)

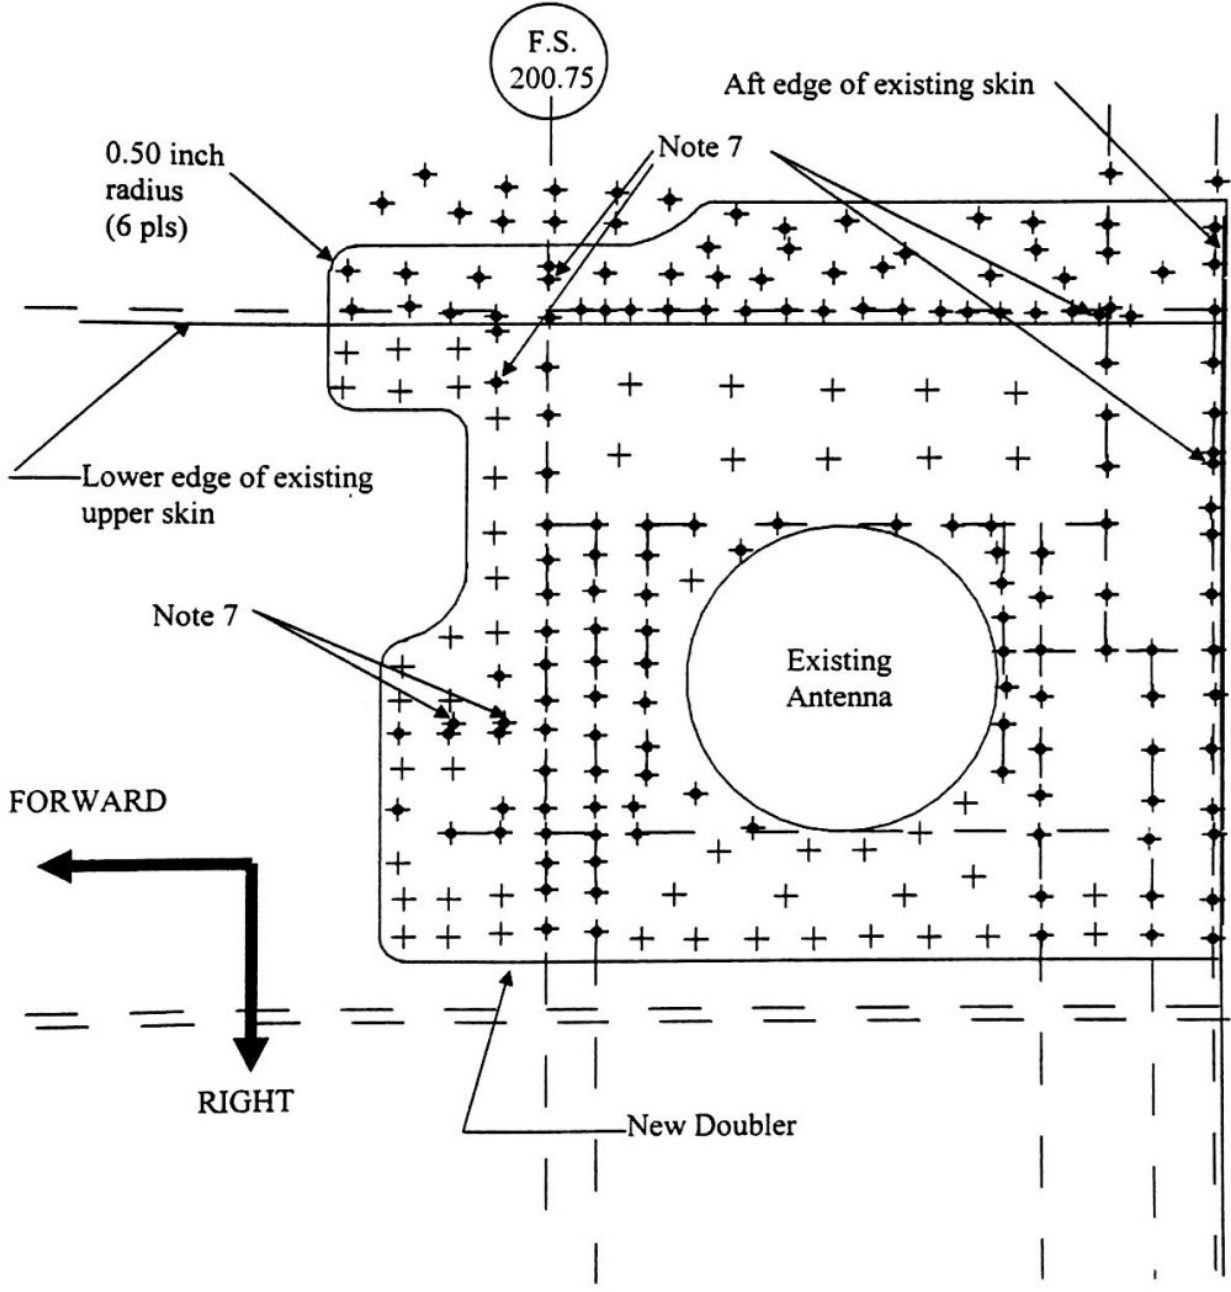
GENERAL ARRANGEMENT - FUSELAGE SKIN REPAIR L.H. SIDE

Report TSA-98-01 required the removal and replacement of the skin with two rows of rivets along each edge of the new skin section. The existing repair complied with this required except for the aft outboard edge on both sides. These edges were completed with only a single row of rivets. Therefore, to properly attach the new skin (installed in 1998) to the existing aircraft structure, a doubler will be added to extend the edge of the skin such that two rows of rivet along the edge will be effective in transferring the shear across the splice.

- 1) Remove rivets as indicated.
- 2) Remove and discard existing antenna. Do not remove internal support structure.
- 3) Fabricate a doubler from 0.032 inch thick 2024-T3 clad. Locate aft edge of doubler at aft edge of existing skin. The overall dimensions and location are determined by including the number of existing rivets and new rivets indicated on page 4.0.2. Ensure that all rivets have an edge distance of 2 times the diameter of the fastener (2d). Ensure that the minimum spacing between any new or new and old fastener is 0.50 inches or 4d, which ever is greater.

- 4) Alodine the doubler using Dorado Kote4 per MIL-C5541A, Type I or equivalent. Prime with zinc chromate.
- 5) Apply sealant Flamemaster Chem Seal CS3204 Class B (MIL-S-8802 Type II Class B-1/2) between the strap and frame.

- 6) Bond countersunk washers in existing countersinks to fill the voids when covered by the new doubler using a structural adhesive per the adhesive manufacturer's instructions.

- 7) Leave these holes open in skin. Do not pick up in doubler. Smooth edges.
- 8) Attach doubler to skin with MS2470E4 rivets in new and existing locations except for those that were countersunk originally, as shown on page 4.0.2. Use NAS1097E4 rivets existing countersunk locations. Install rivets per AC 43.13-1, Chapter 4. Ensure the number of rivets indicate on page 4.0.2 are included. Field rivets should be located approximately as shown, but no closer than 6d to any adjacent rivet. Shim as necessary between existing skin and doubler to prevent excessive pull-up.

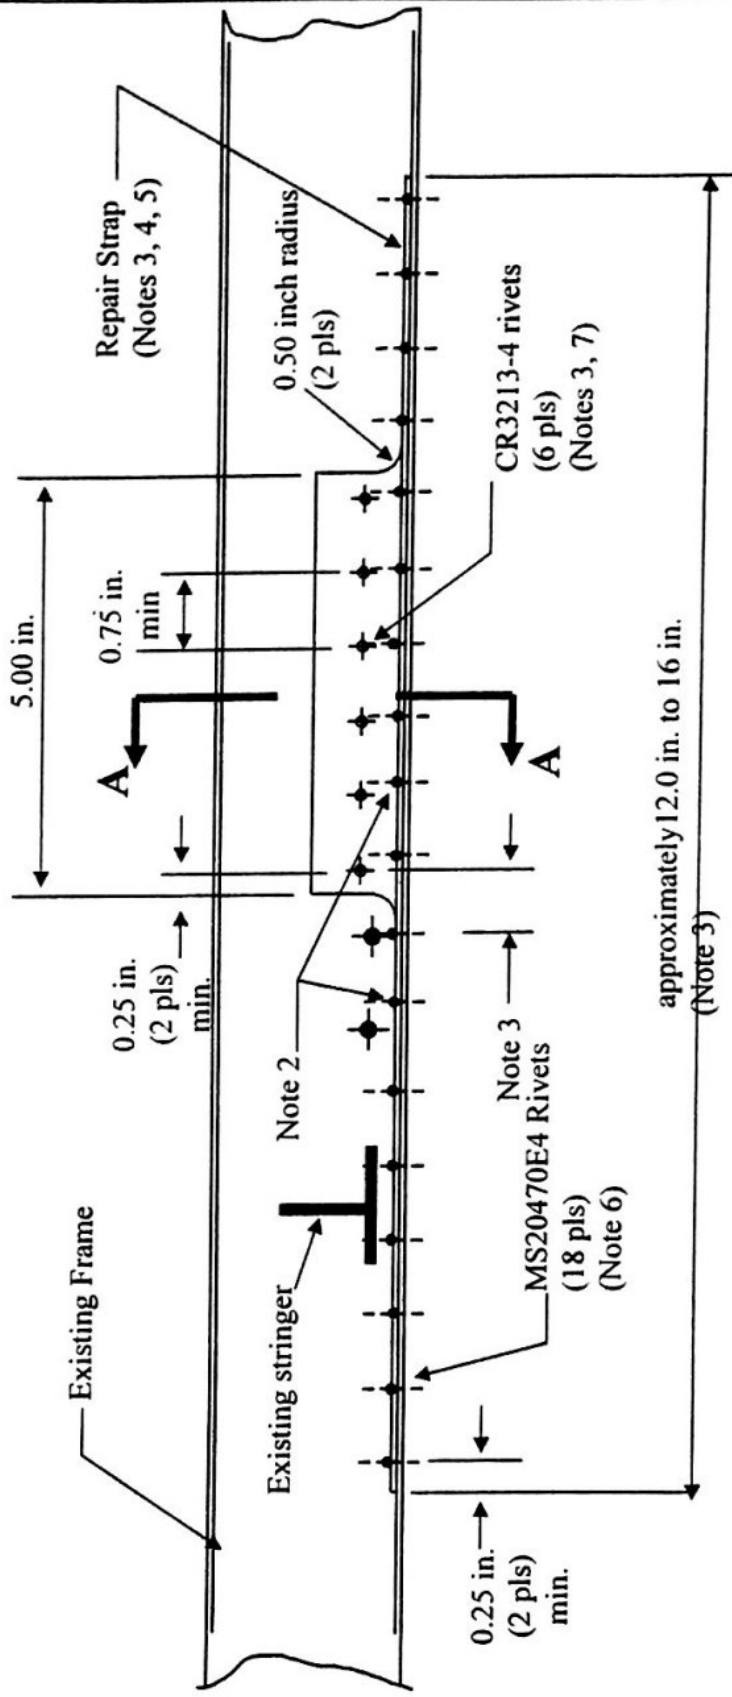
GENERAL ARRANGEMENT - FRAME REPAIR

Report TSA-98-01 required the removal and replacement of the frame at F.S. 211, left hand side from lower centerline of the airplane up to W.L. 83.92. This frame consists of two formed channels spaced apart and attached to the skin. The replacement part for the forward channel appears to be a used channel taken from another airplane. The used part included existing fastener holes for the skin, which did not line up with the existing holes in the skin for this airplane. Therefore, GTA Air found several open holes in the newly installed used part and (3) were found to be must too close to the rivet locations for this airplane. Therefore, a strap is added to repair the holes too close to existing holes in the skin.

The repair strap is made from 0.063 inch thick 2024-T3C. The strap is provided to replace the transfer of shear capability of the three rivets too close to existing holes in the previously installed repair frame section. The strap is designed to allow the equal shear load carried by the existing rivets to transfer through the vertical leg of the strap into the existing frame section. Also, attachment of the strap to the existing frame is designed to equivalent strength of the existing frame flange.

- 1) Remove rivets as indicated.
- 2) Insert a thin piece of steel between the fuselage skin and frame at the two miss-drilled holes. Elongate only enough to remove segment between the holes and remove sharp corners.

- 3) Fabricate the repair strap from 0.063 inch thick 2024-T3 clad. Overall length of part is dependent on the spacing of the existing rivets indicated. Ensure that the end rivets have a minimum edge distance of 0.25 inches. Form the vertical leg of the strap to nest inside existing bend radius of frame. Ensure bend radius of strap does not fall below the minimum for 0.063 inch thick 2024-T3C per AC 43.13-1, paragraph 4-55. **POSITION THE VERTICAL LEG SUCH THAT THE NEW RIVETS DO NOT LINE UP WITH EXISTING HOLES IN THE FRAME. LENGTH OF VERTICAL FLANGE MAY VARY DEPENDING ON THIS REQUIREMENT.**

- 4) Alodine the repair strap using Dorado Kote4 per MIL-C5541A, Type I or equivalent. Prime with zinc chromate.
- 5) Apply sealant Flamemaster Chem Seal CS3204 Class B (MIL-S-8802 Type II Class B-1/2) between the strap and frame. Fill holes to remain open in existing frame with sealant.

- 6) Attach strap to frame and skin with noted MS20470E4 rivets per AC 43.13-1, Chapter 4. **RIVETS THROUGH THE FRAME AND SKIN ARE EXISTING AND DO NOT INCLUDE THE OPEN HOLES!** Acceptable to use MS20470E5 rivets where 0.125 inch diameter rivets will not install properly. Do not install rivets larger than 5/32 inch diameter.

- 7) Attach vertical leg of strap to frame with 1/8 inch diameter Cherrymax Rivets CR3213-4, per manufacturers instructions.

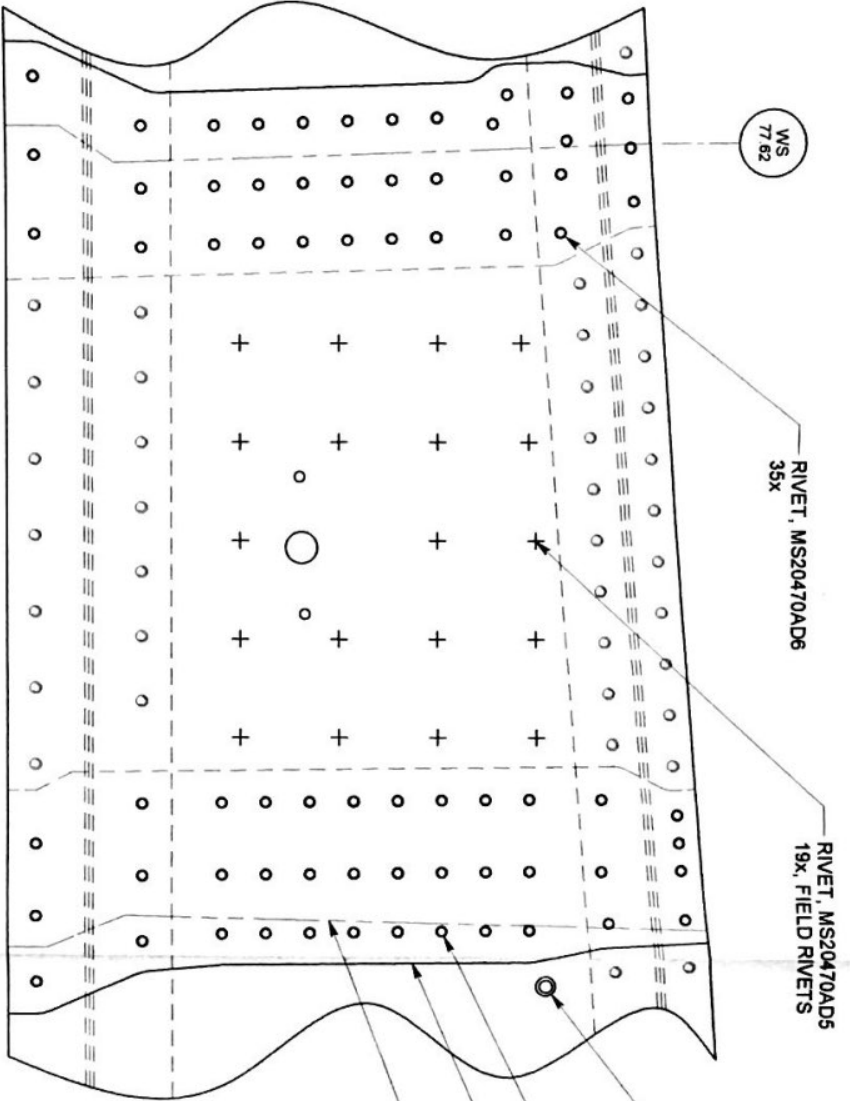
-101 REPAIR INSTL
(VIEW LKG UP AT LWR WING SKIN)

The lower right hand wing skin is found to be damaged. The wing skin is made from 2024-T3 clad sheet .063 thick. The skin must support ultimate loads of minimum section which occurs just inboard of the damaged area. The minimum sectional length is $7.6 - 1.1 - .156 = 6.344$ inches. The ultimate loss in strength of the skin section is $.063(6.344)(60000) = 23980$ lbf. The doubler installed is made from .063 thick 2024-T3 clad sheet. The minimum section of the doubler is $9.69 - 9(.156) = 8.284$ inches. The minimum strength of the doubler is $8.284(.063)(60000) = 31313$ lbf.

- Research validity of lower skin splice @ STA 81.44 to 92.94. Replaced splice and doubler IAW 8110-3, 04-107-02 dated 02 SEPT 04
- L/H wing, remove auto body filler, shim aft O/B engine beam to proper skin contour, and replace blind fasteners in lower nacell skin @ STA 93.44 and 111.94.

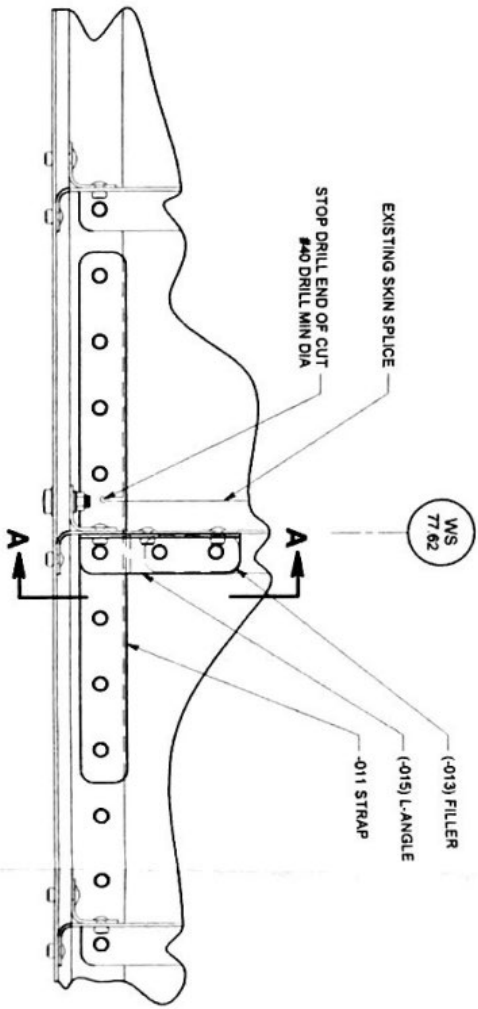
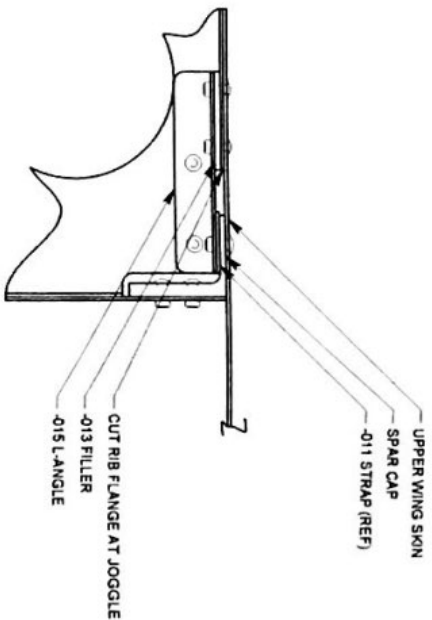
-101 REPAIR INSTL
(VIEW LKG UP AT RH SIDE AFT WING SPAR)

The upper rear spar cap is partially cut. The cut length is .30 inches. The spar cap is .090 inches thick. The material of the cap is 2024-T3511 which has the following material properties;

- R/H wing flap well, Fabricate and install doubler for upper aft spar cap @ STA 76.94 IAW 8110-3. 04-107-01 dated 02 SEP. 04
- R/H wheel well butt rib/ false spar mating point, @ STA 58.94, replace I/B end of the false spar web. And replace blind fasteners as needed. Reassure all pre-existing fasteners are of the correct type.

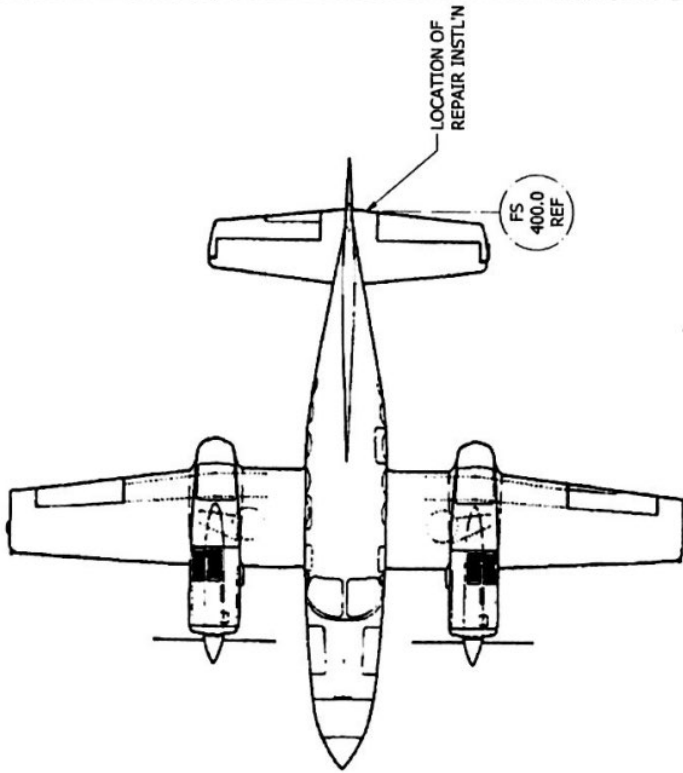
FIG 1 - LOCATION OF REPAIR INSTALLATION
 (NOT TO SCALE)

1. THIS DRAWING DEFINES THE REPAIR TO DAMAGE TO THE EXISTING HORIZONTAL STABILIZER (H-STAB) LOWER SKIN PANEL AT THE TRAILING EDGE. THE REPAIR INVOLVES TRIMMING/REMOVING THE EXISTING TRAILING EDGE, INCLUDING DAMAGED SKIN, AND THE INSTALLATION OF A STIFFENER, SIMILAR TO THE AIRCRAFT FLAP DESIGN. THE REPAIR IS LOCATED AT FS 400.0 (+/-2.0") AND ALONG THE AIRCRAFT CENTERLINE, AS SHOWN.

6. TRIM OFF EXISTING H-STAB TRAILING EDGE, AS SHOWN. ENSURE ALL DAMAGE HAS BEEN REMOVED, BY PERFORMING A DIE PENETRANT INSPECTION OF THE SKIN PANEL PER THE AIRCRAFT MAINTENANCE MANUAL/STRUCTURAL REPAIR MANUAL (AMM/SRM). IF DAMAGE REMAINS, CONTACT STRONG AERO ENGINEERING FOR DISPOSITION

7. ADJUST -01 HEAVY DUTY STIFFENER LENGTH TO MATCH THE EXISTING H-STAB SKIN PANEL, AS SHOWN
8. WET INSTALL -01 HEAVY DUTY STIFFENER TO MIL-S-8802 (OR EQUIVALENT)

9. MAINTAIN 2D EDGE AND 4D PITCH DISTANCE MINIMUMS ON ALL RIVETS HOLES
10. FUNCTION CHECK THE AIRCRAFT ELEVATOR SYSTEM, PER THE AIRCRAFT AMM, POST REPAIR INSTALLATION

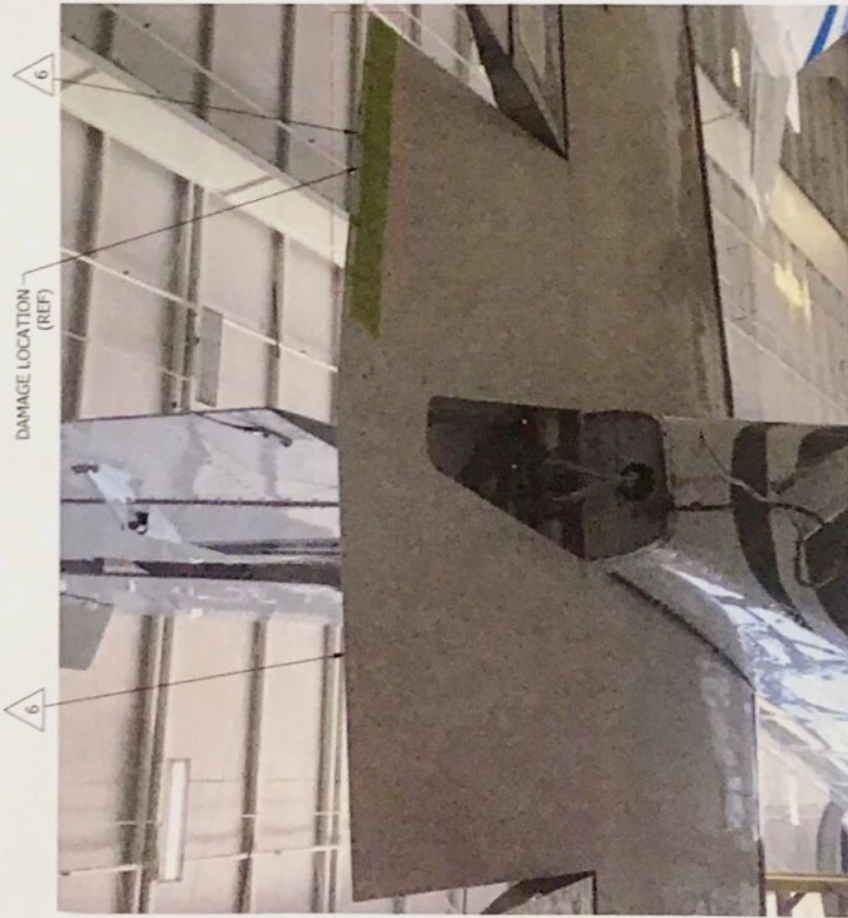
FIG 2 - PHOTO LOOKING UP AND FORWARD AT DAMAGE LOCATION

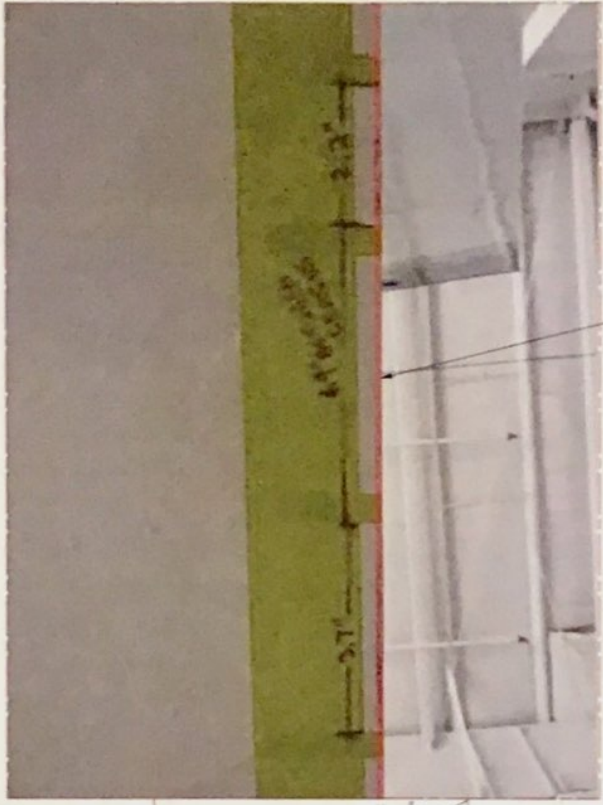
FIG 3 - PHOTO LOOKING UP AT DAMAGE

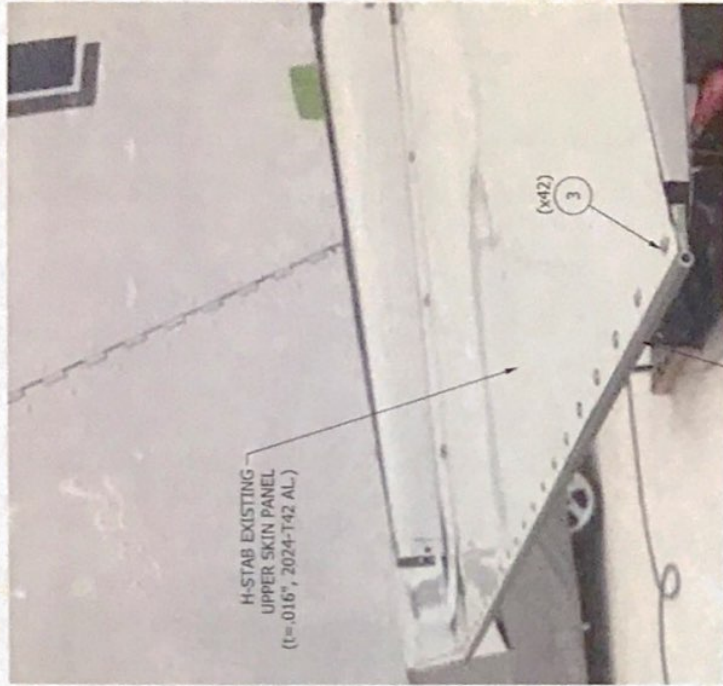
FIG 5 - PHOTO OF REPAIR POST INSTALLATION
