MEL-57-01

WINGS - FORWARD LOWER SPAR CAP INSPECTION

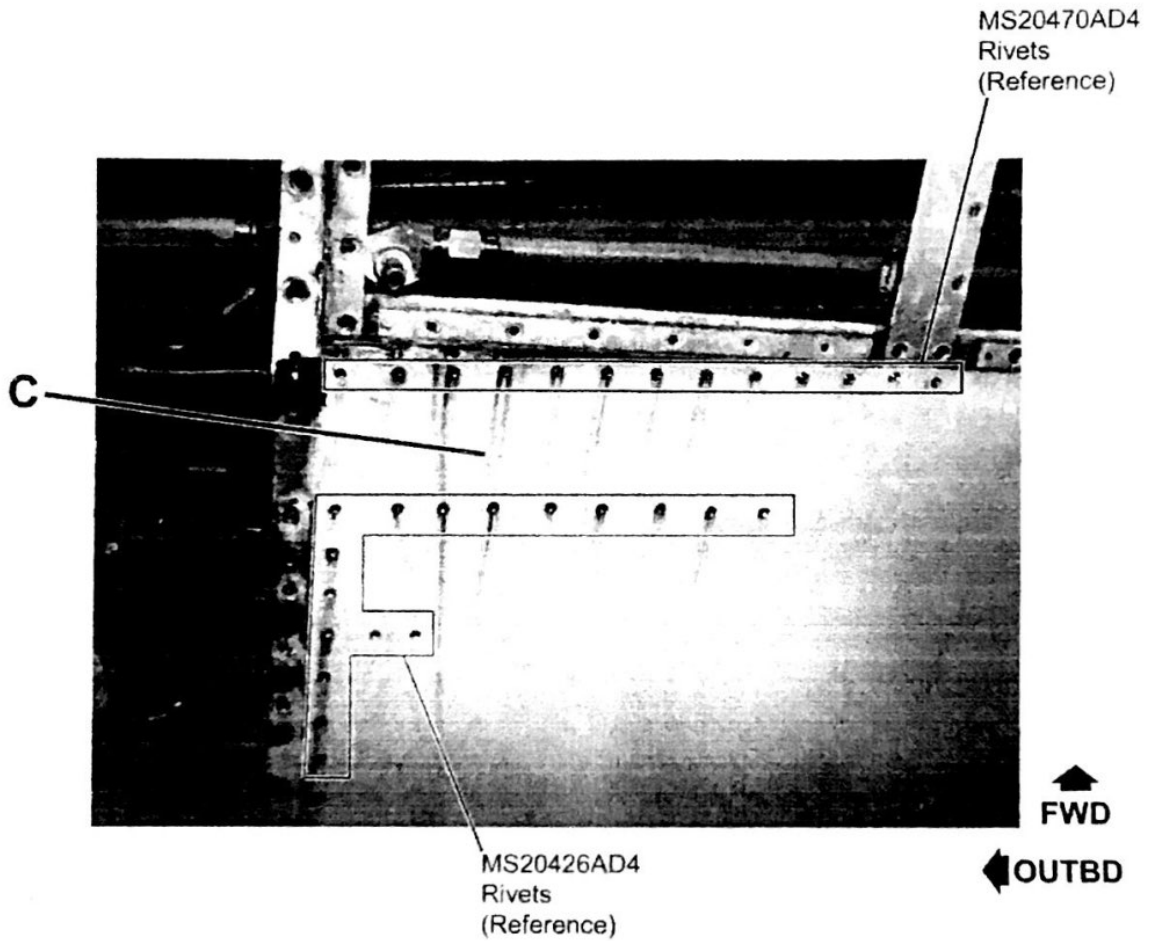
Figure 1. Carry Through Spar Cap Inspection (Sheet 2)

DETAIL B

Airplanes Without Forward Spar Access Panel

NOTE: For airplanes that do not have access panel installed.
The rivet length determined at time of installation.
