Inspection of N20313

for Ron Snider
Crescent City CA Airport (CEC)
Date Inspected: 6/8/19

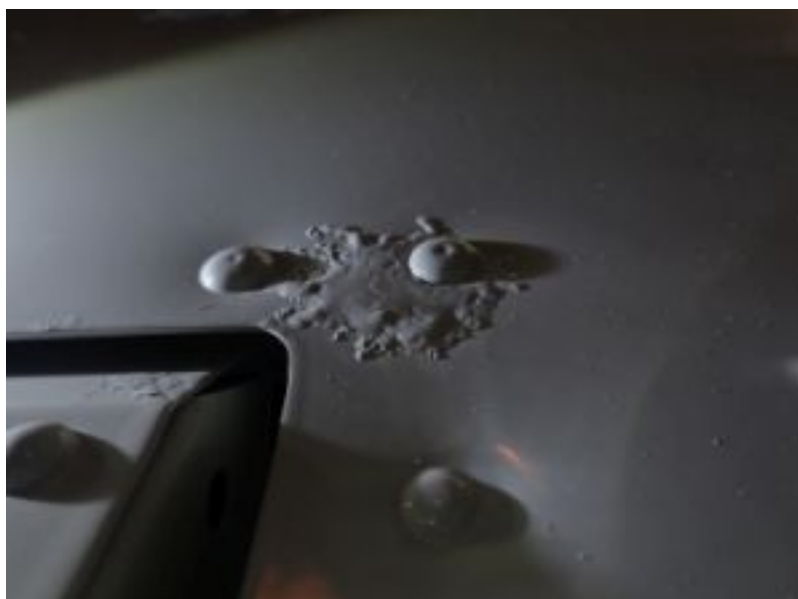
Filiform corrosion.

- There are a number of areas of filiform corrosion which should be cleaned and painted to protect the skins.
- The cylinders have some signs of rust pitting which increases the chance that a top overhaul may be required. The first clue will be increased or excessive oil burn.

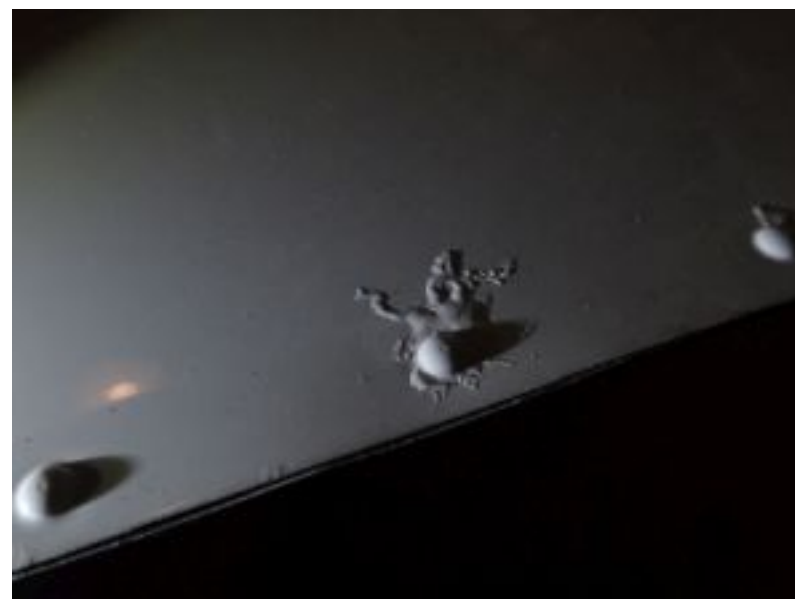
Filiform corrosion.

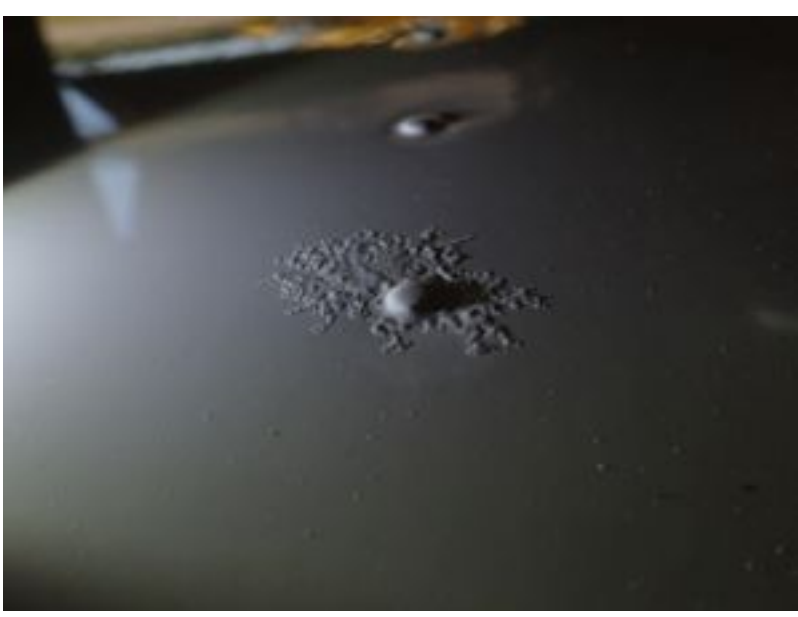
Filiform corrosion.

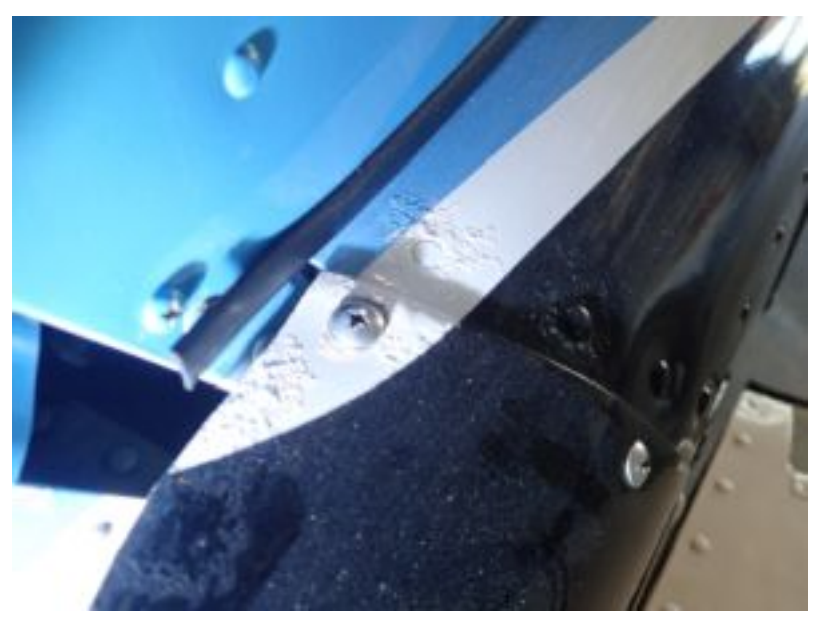
Filiform corrosion.

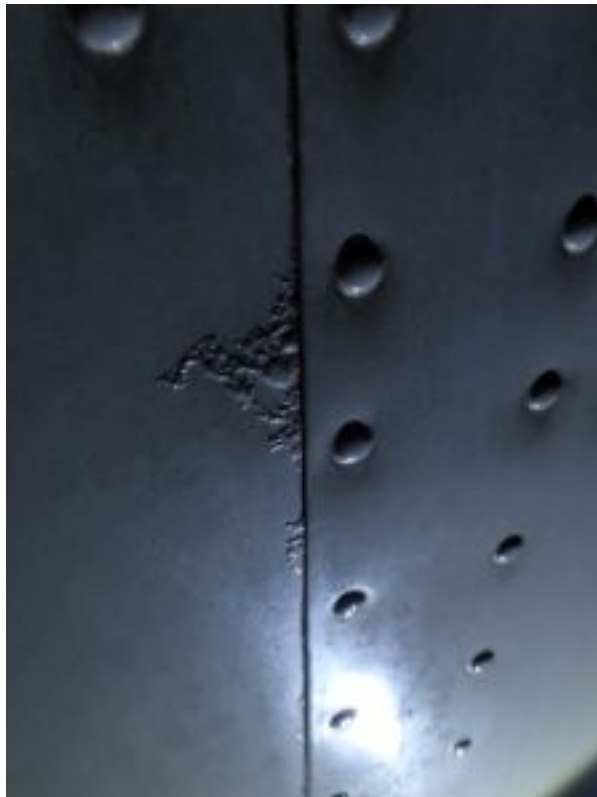
Filiform corrosion.

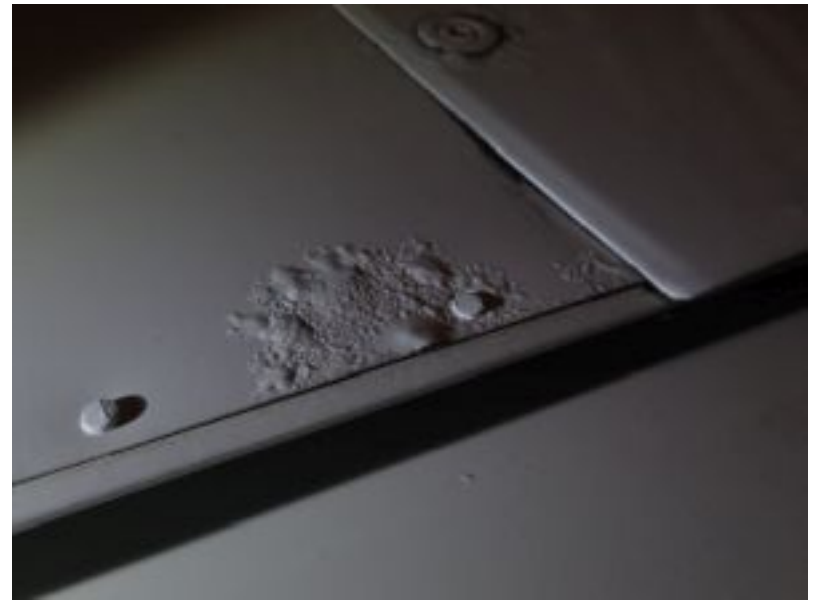
Filiform corrosion.

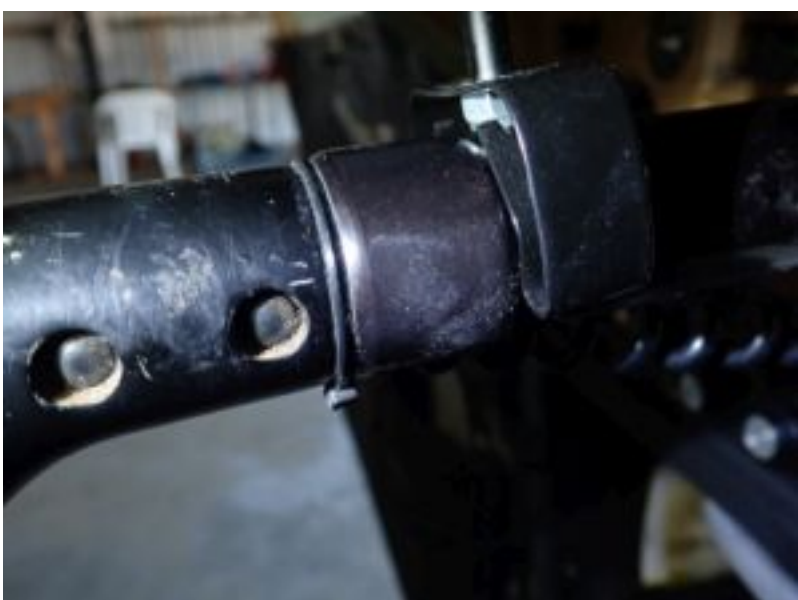
Pilot's yoke was loose.

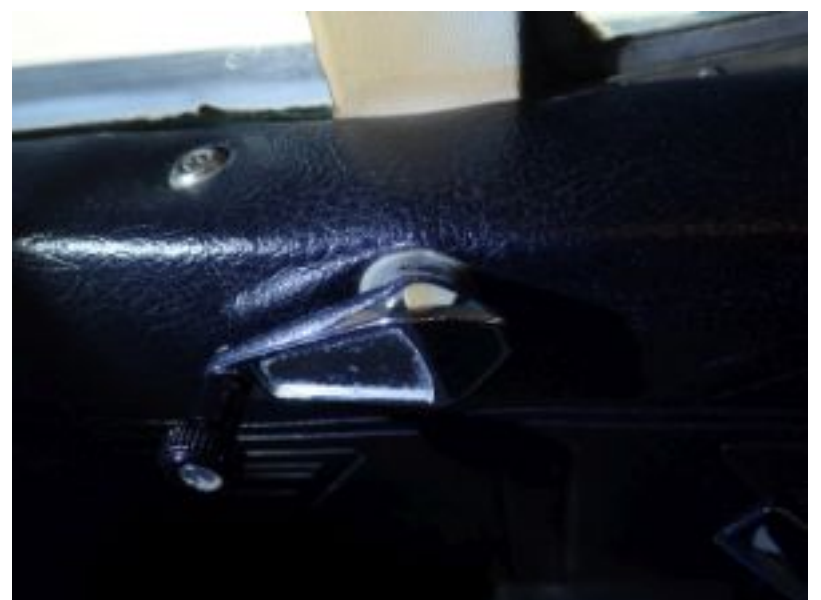
Wing vents needed lubrication

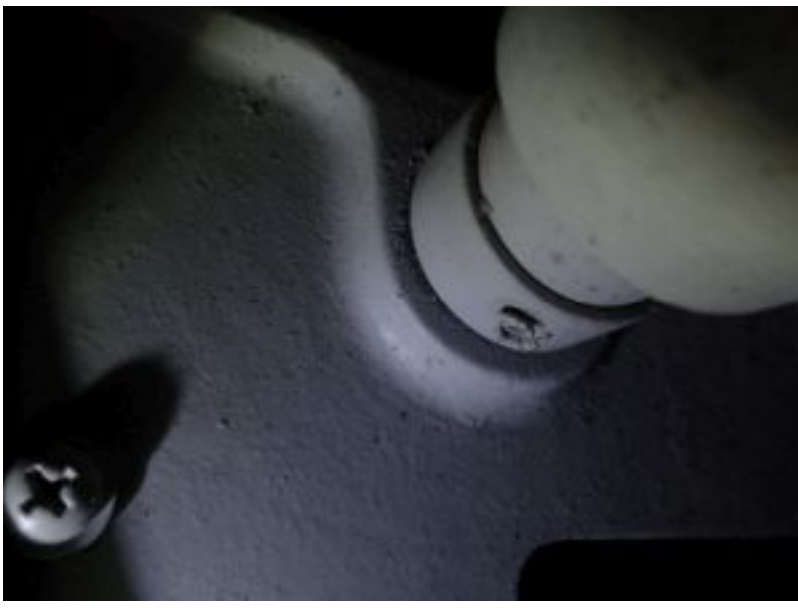
Seat pivots were bound, needed lubrication.

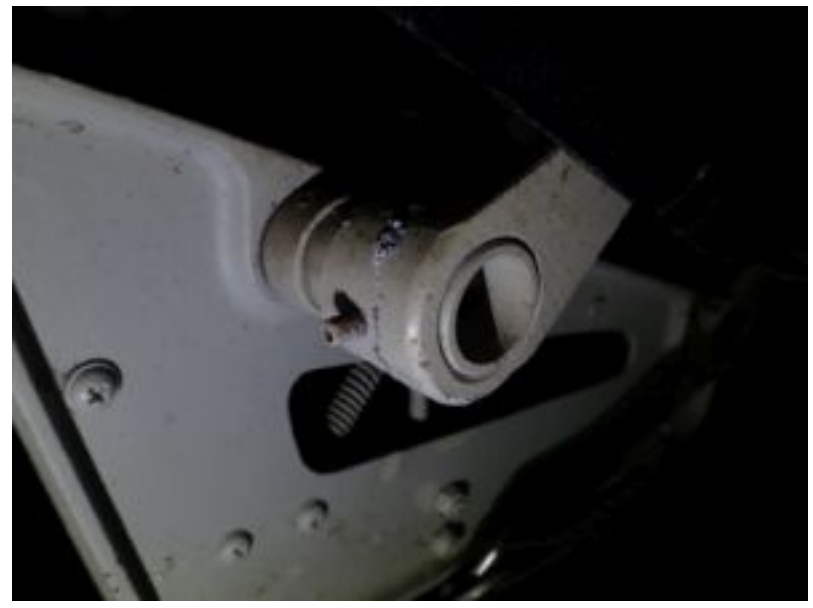
One roll pin was sticking out, tapped back in.

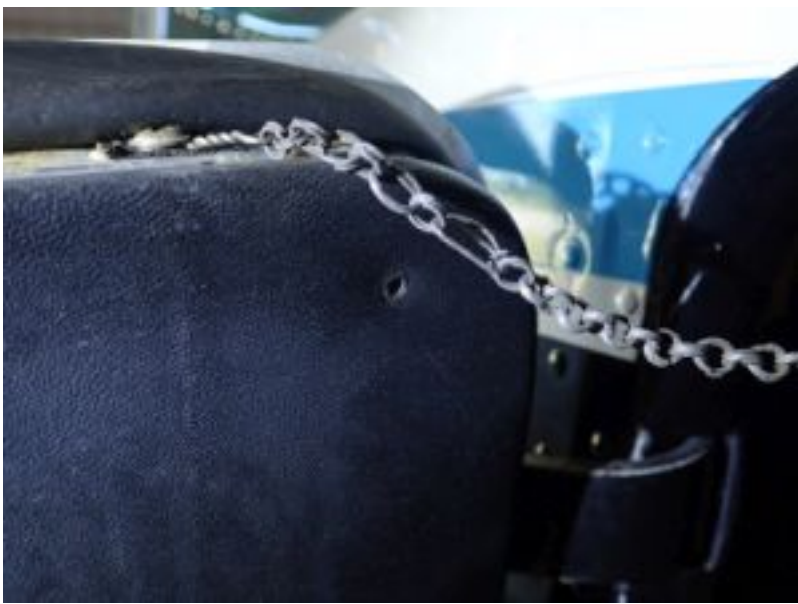
Two repairs on the baggage door chain, could be improved a bit.

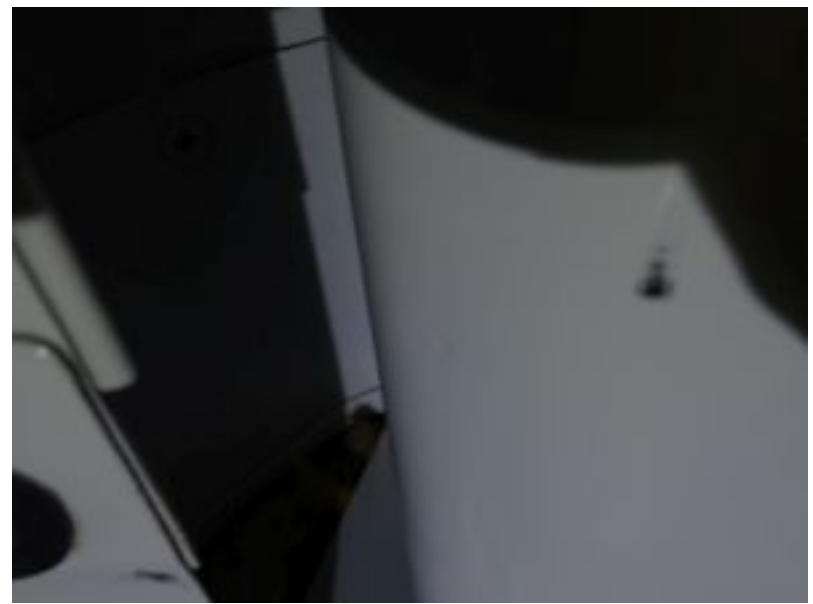
Poor picture of this... long screws in the under-wing gap seal are making dents on the flaps.

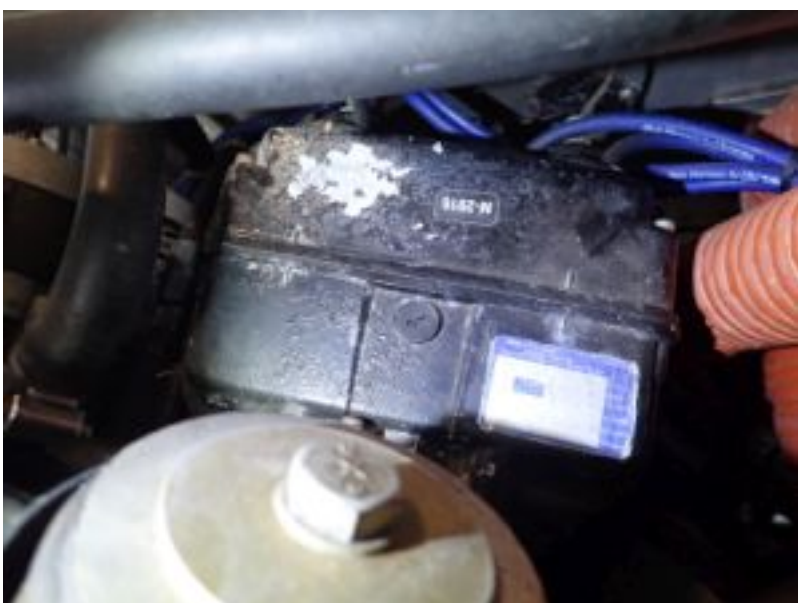
Corrosion on the mag case is very concerning, should be cleaned and painted.

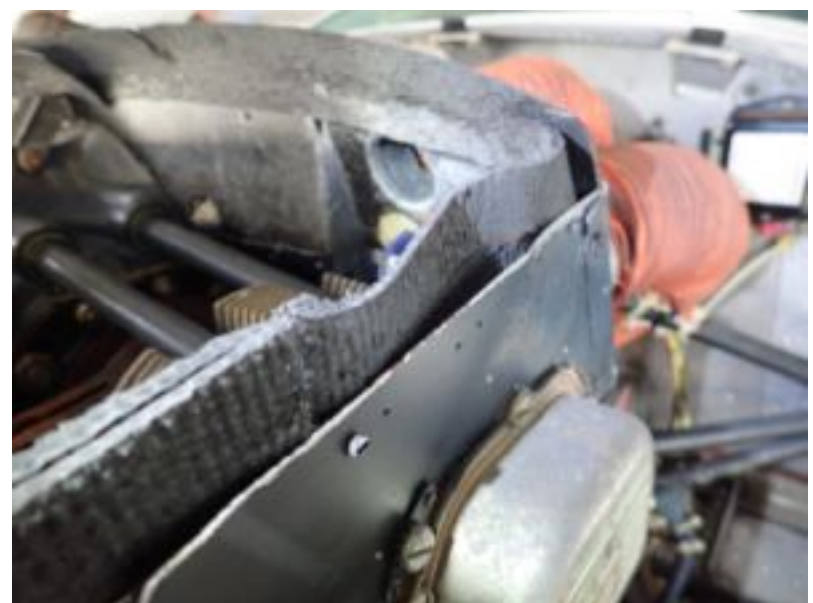
Engine baffle seals are wearing into the cowl, should be protected with aluminum duct tape or epoxy paint.

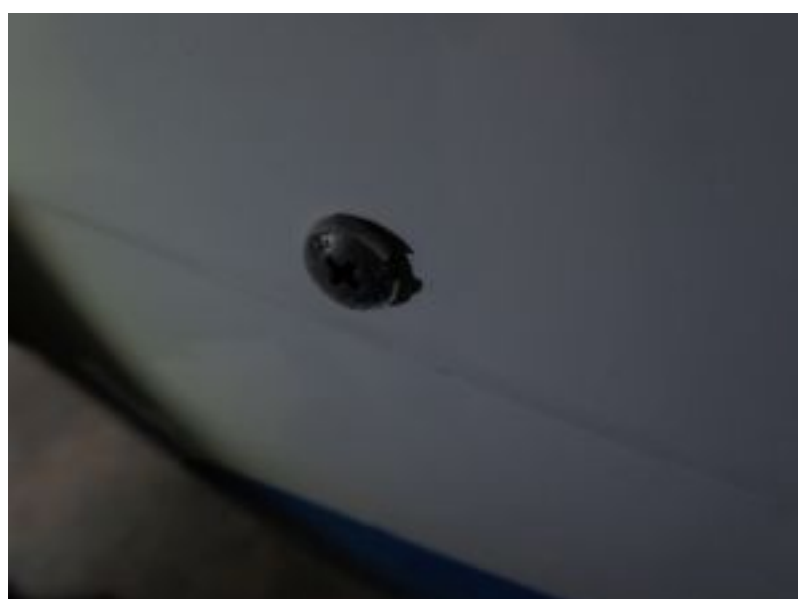
Some cowl screws are 'pulling through' as they are worn out.

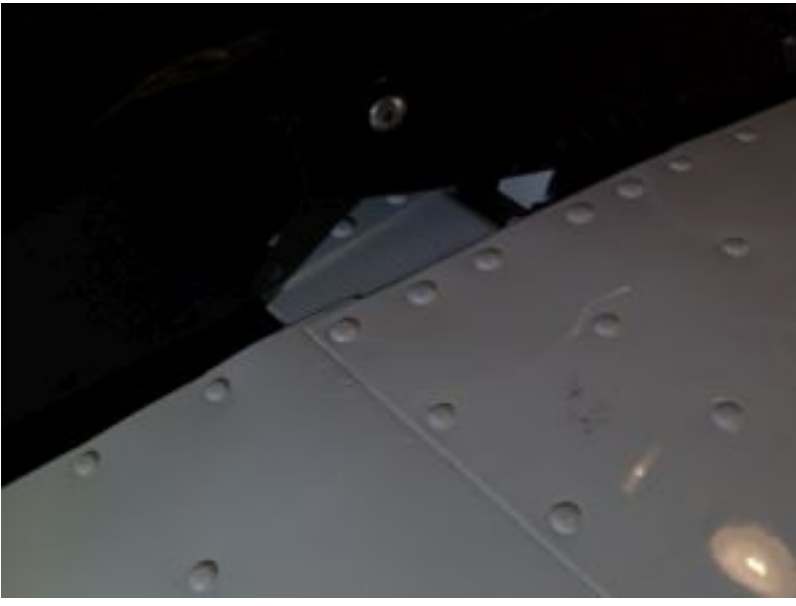
Stab is slightly loose.

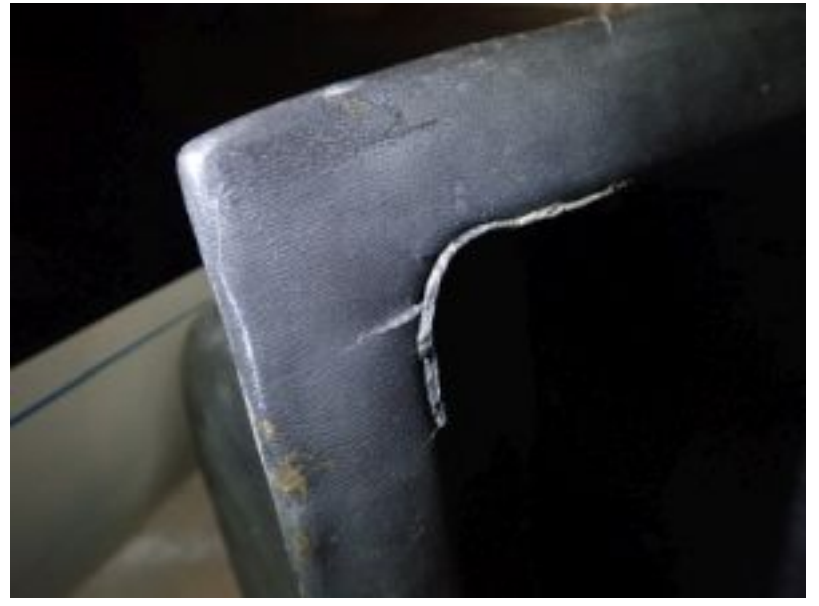
Cracking on baggage bulkhead could be reinforced with Fiberglas.

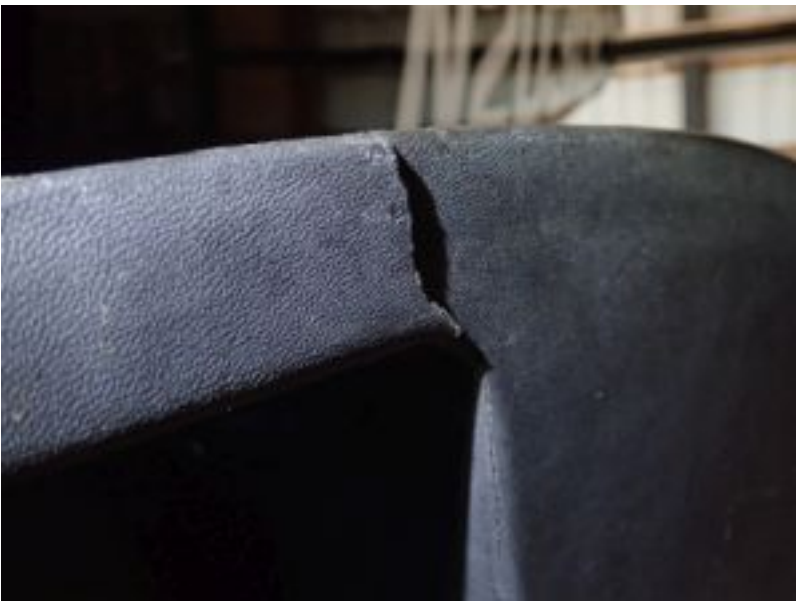
Bulkhead cracks... Fiberglas will make it last, or get a new one.

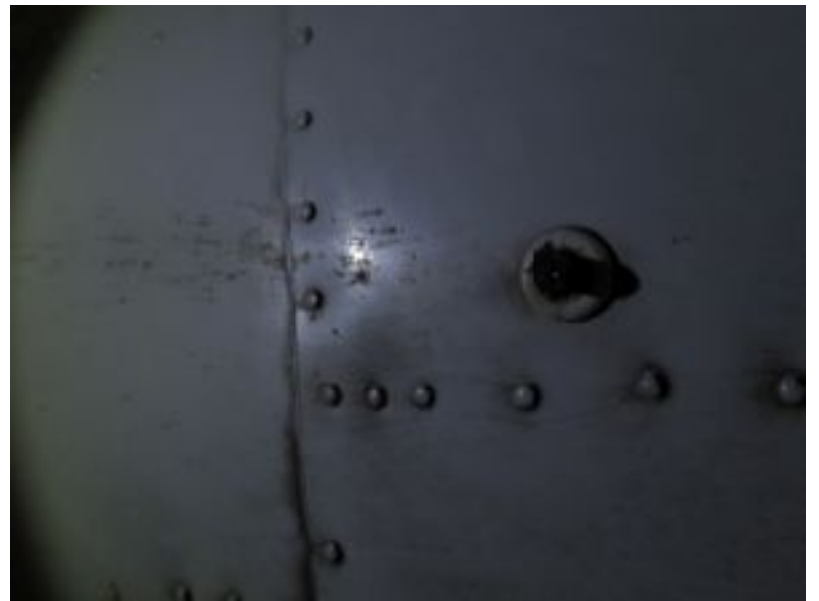
Battery acid is eating the paint behind the battery drain, best to clean it up and protect it.

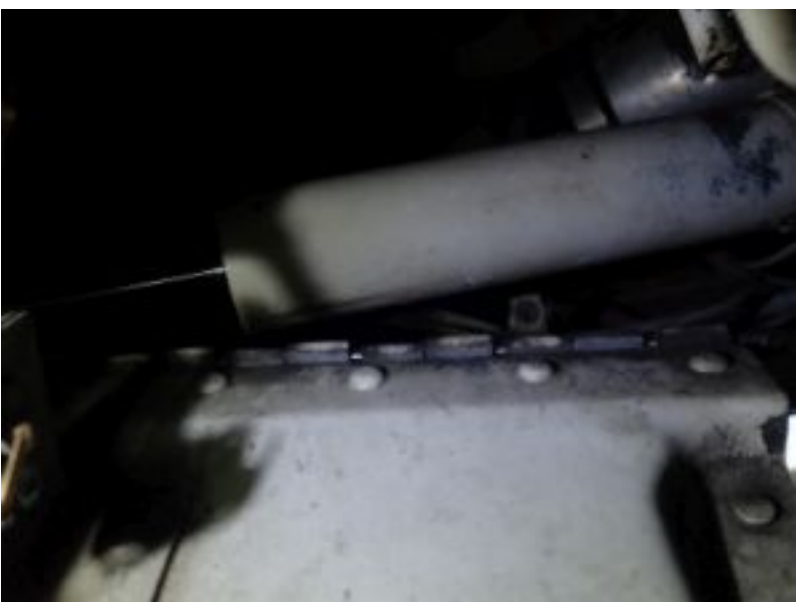
Very worn cowl flap hinge.

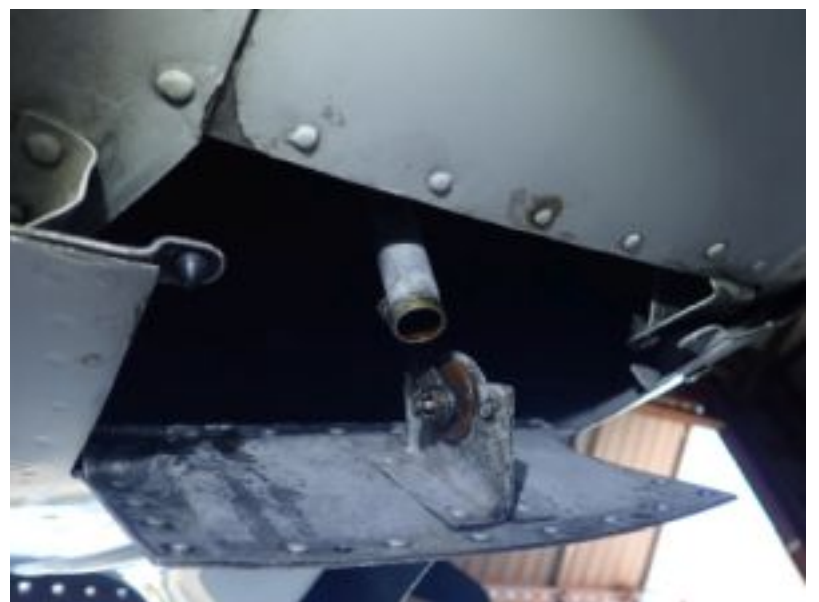
Missing cowl flap bumper.

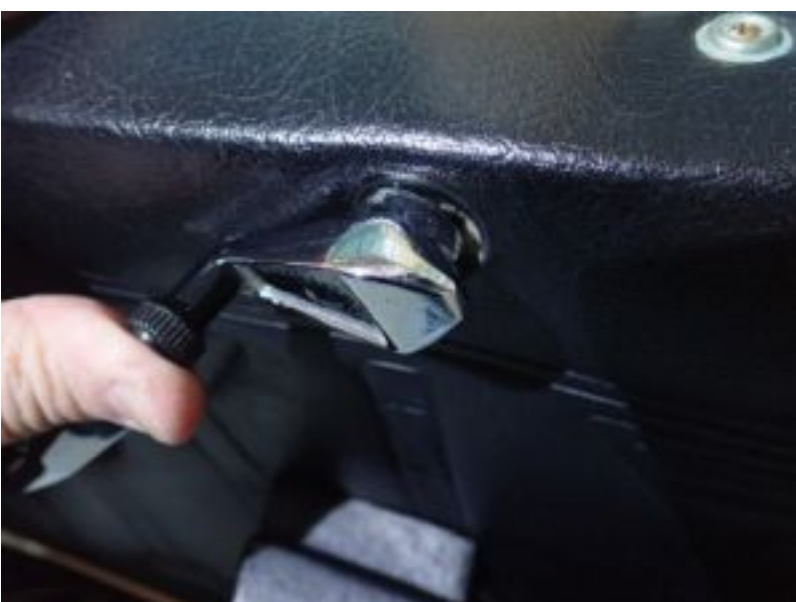
Vent window crank was very worn, ideally find a way to repair or replace it.

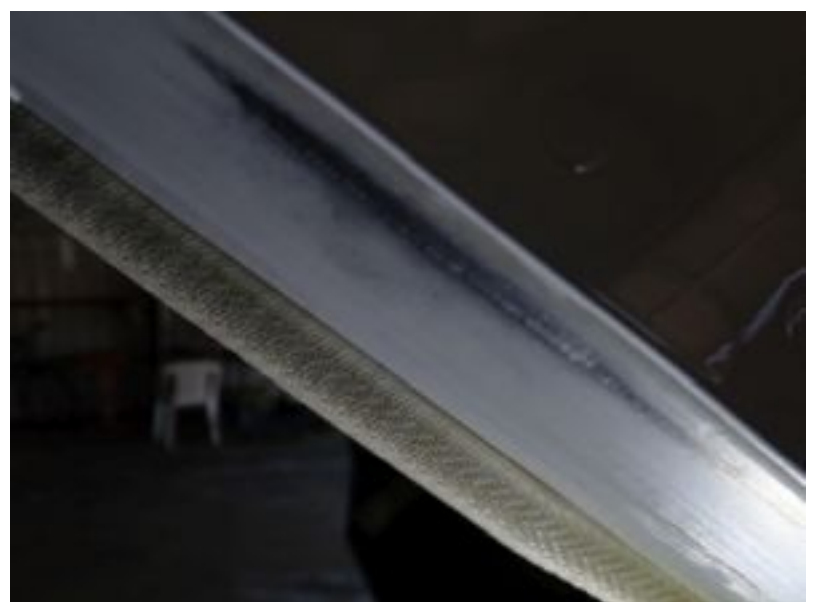
Wear on door frame, adjust the door flange so this no longer wears to avoid future problems.

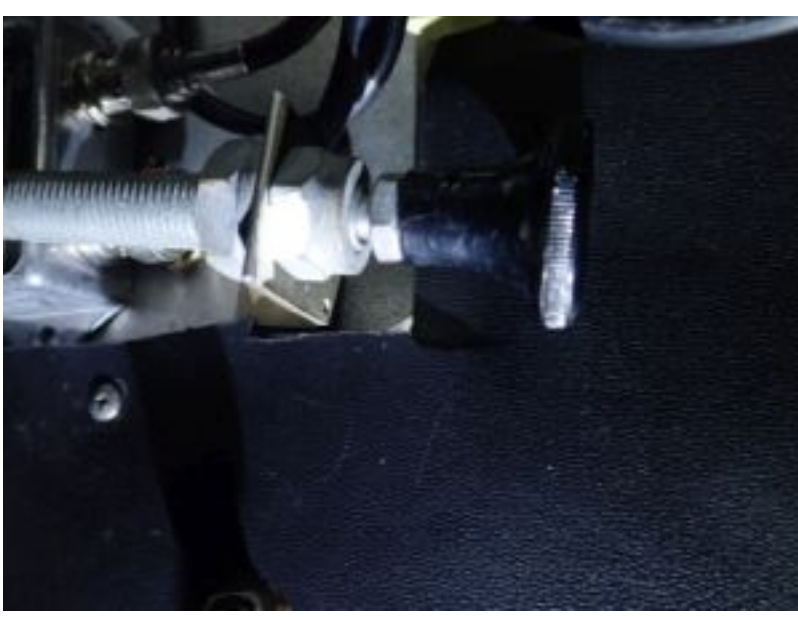
Frangible safety wire missing on fuel shutoff handle.

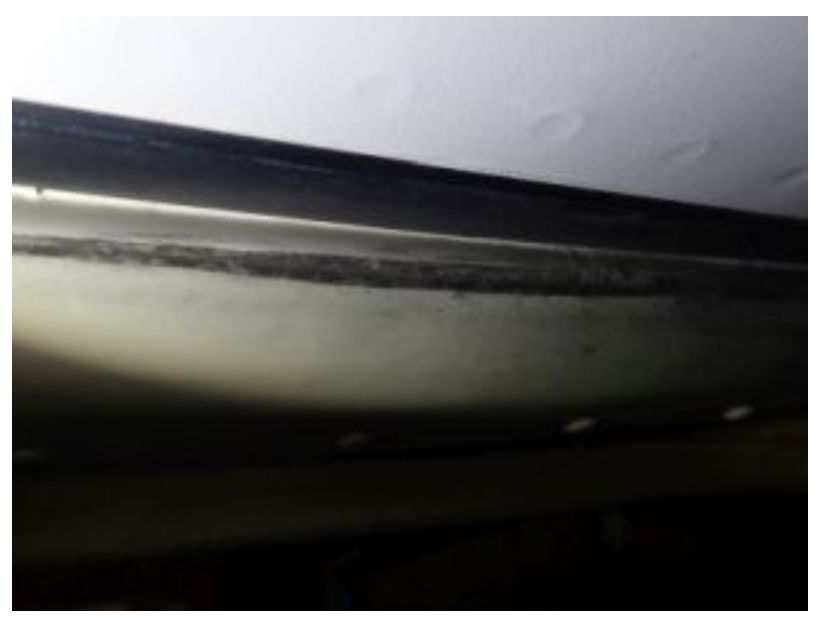
Another wear point on the door frame.

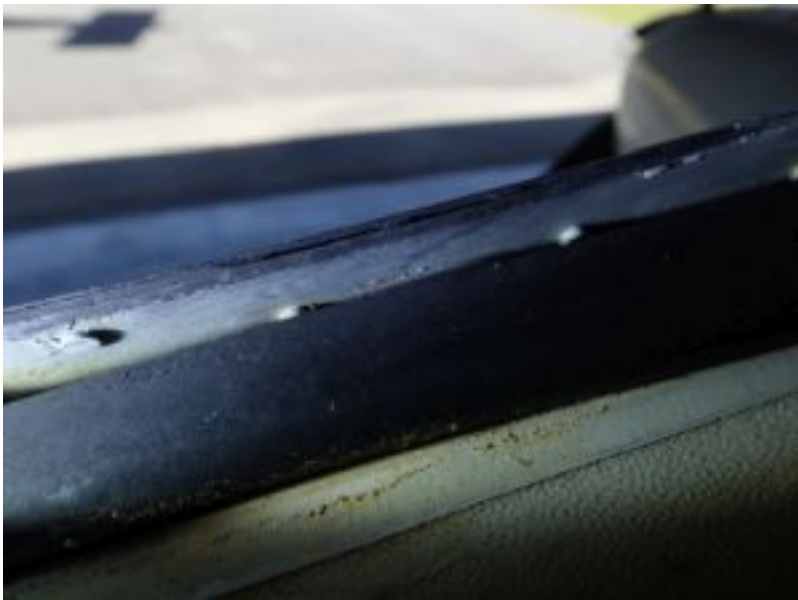
This is the part of the door which needs to be shortened to stop the wear on the frame.

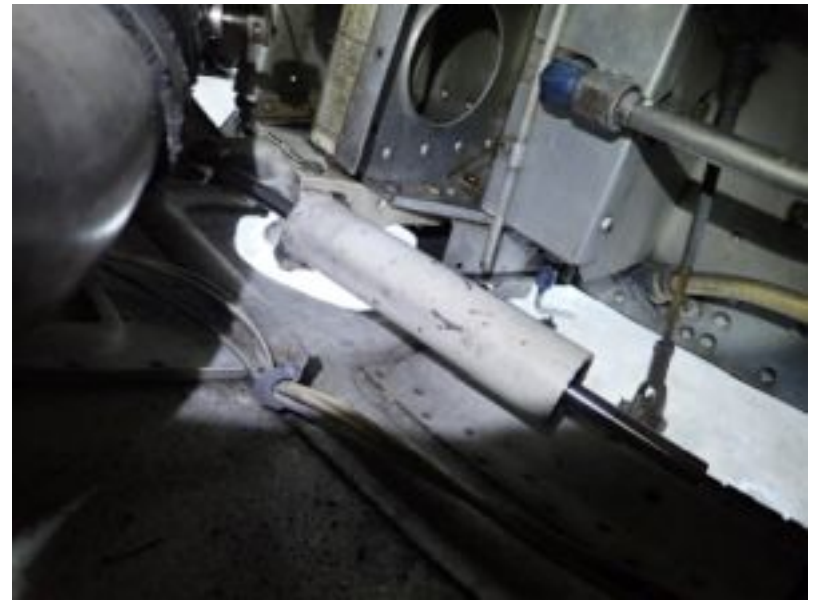
Shimmy dampener should have a placard to help avoid future problems.

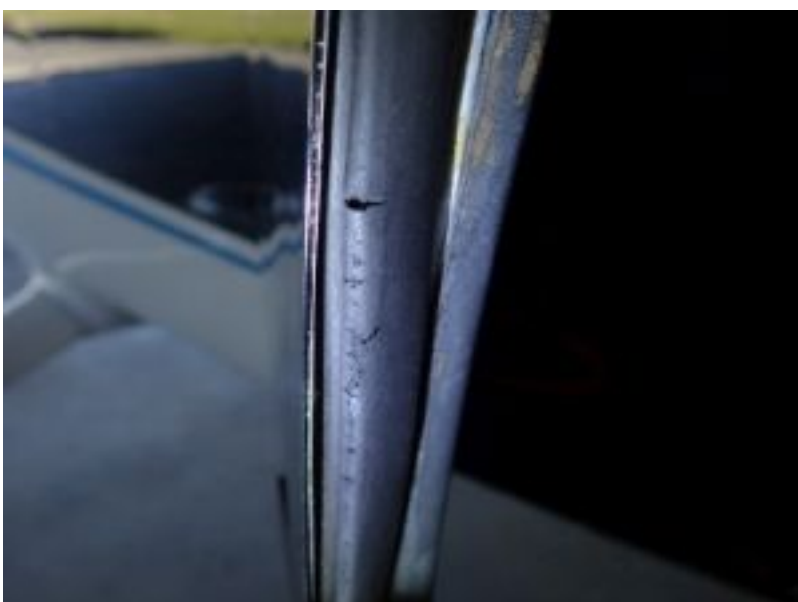
Door seals are a soft but wearing.

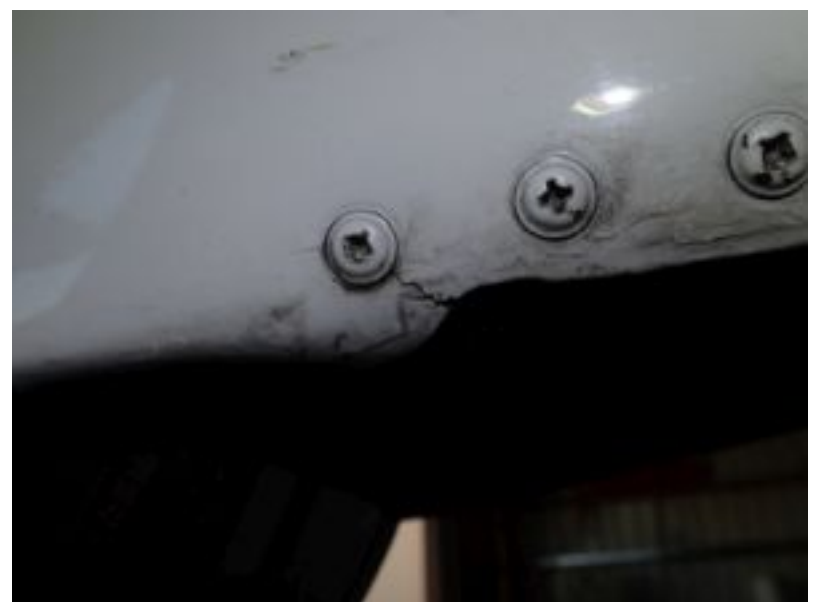
Small cracks on the nose wheel pant, perhaps could be strengthened with Fiberglas?

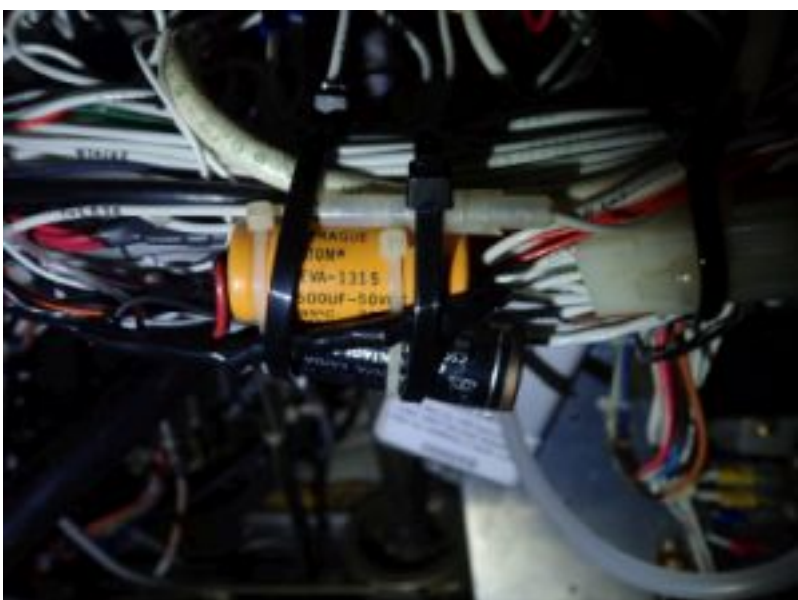
Over Voltage switch is installed, could cause trouble later. Just remember it is there so you'll know where to look when trouble comes.

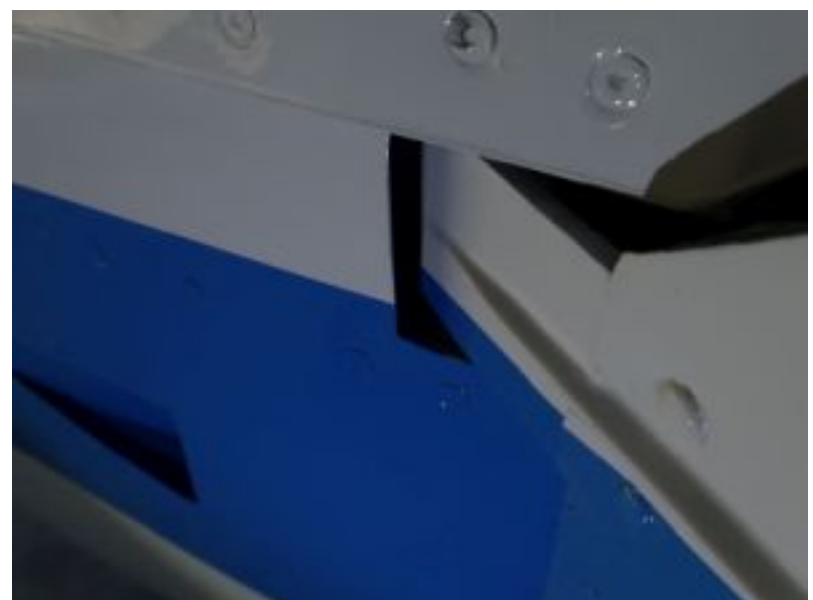
Some early looseness on the door hinge.

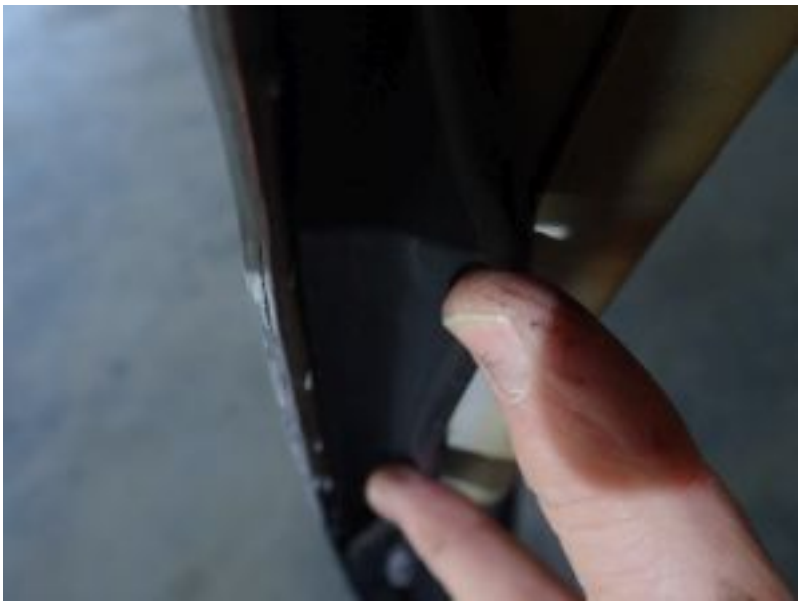
One of the door seals was installed with wrong edge glued down.

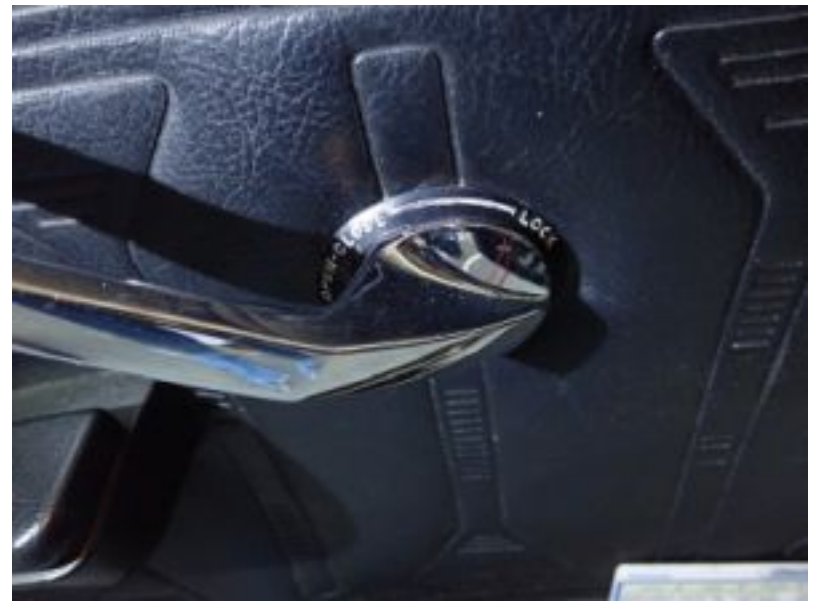
Door handle on one side had a loose bushing/shaft.. may need a rebuilt one in time, or it could be loose mounting screws. We can hope!

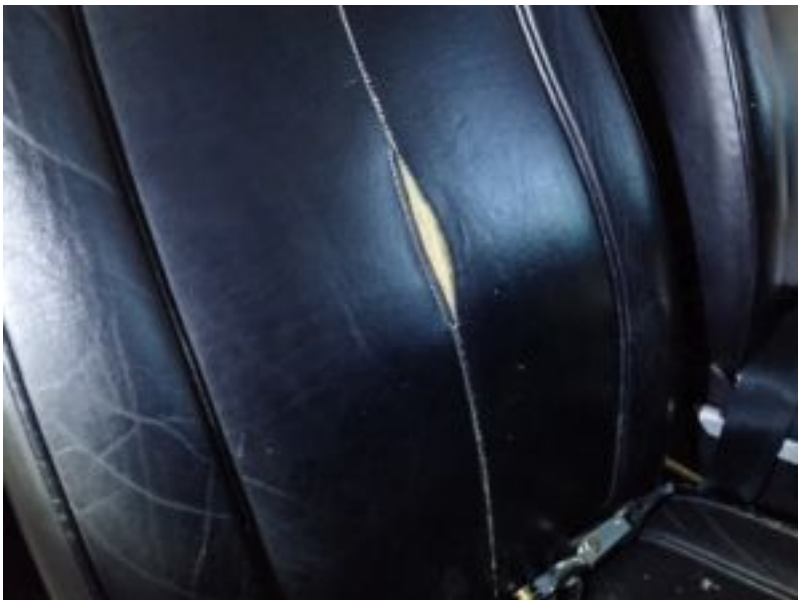
Tear in the copilot seat back...

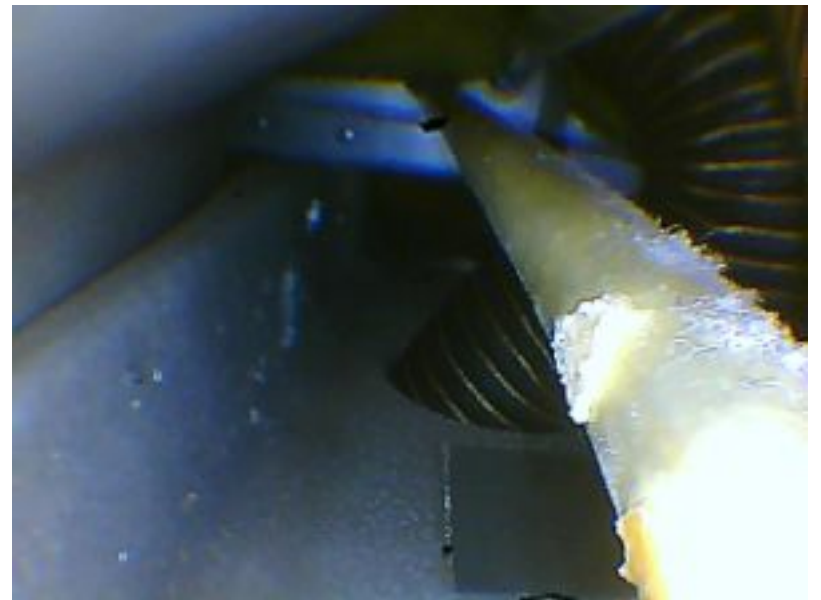
Just one area which could be corrosion on the fuel vent tube in the overhead, or it could be mud from a dauber's nest.

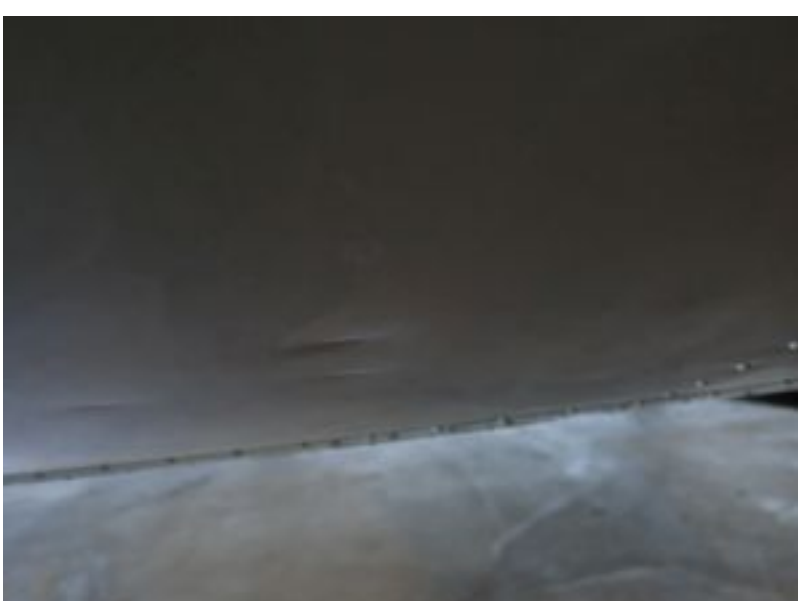
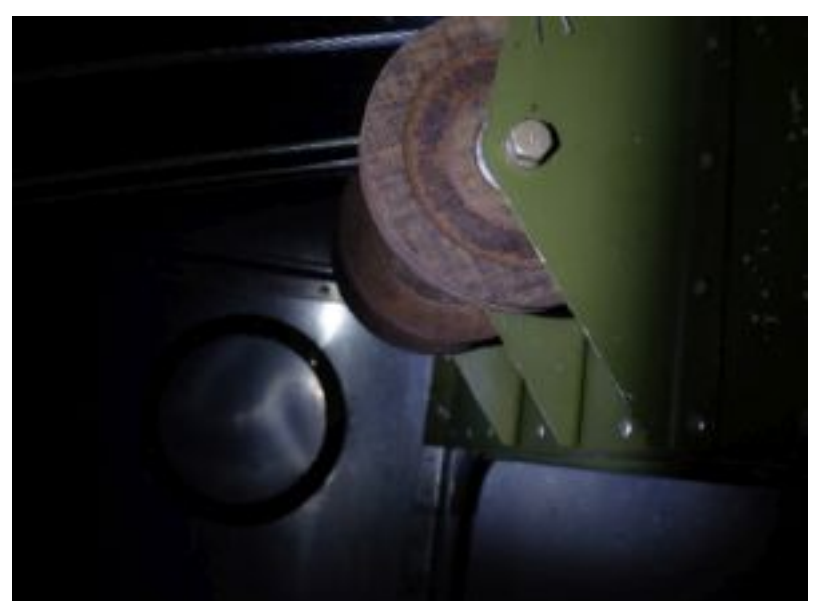
A couple of small dents under the stab.

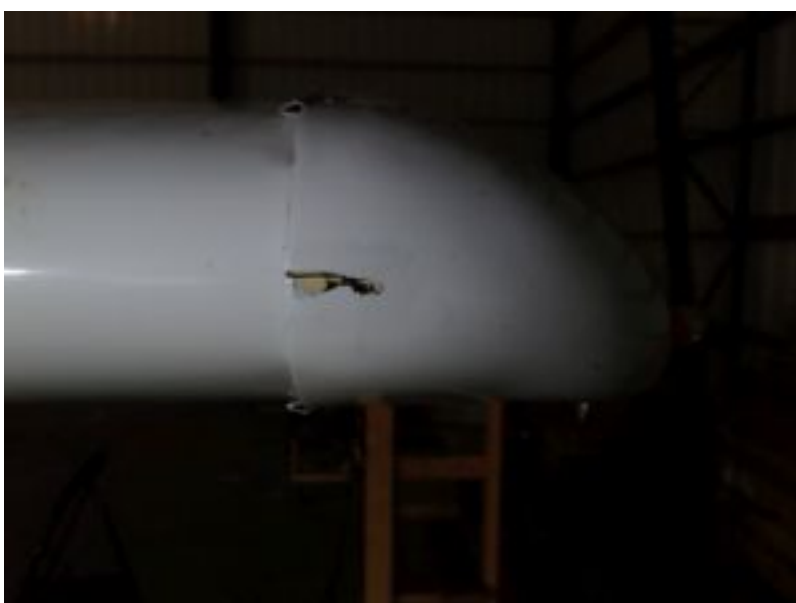
Wing tip crack.

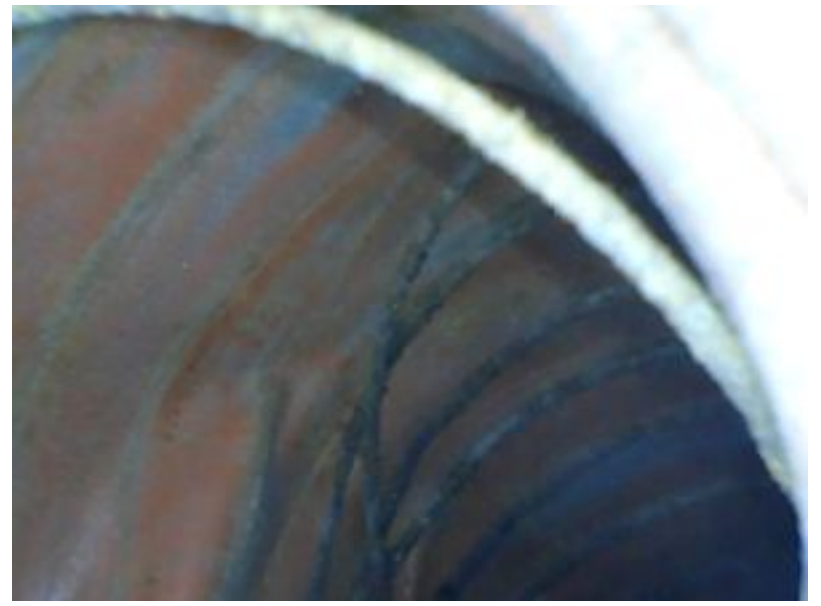
Loose spiral inside SCAT at back of engine baffle, should be replaced.

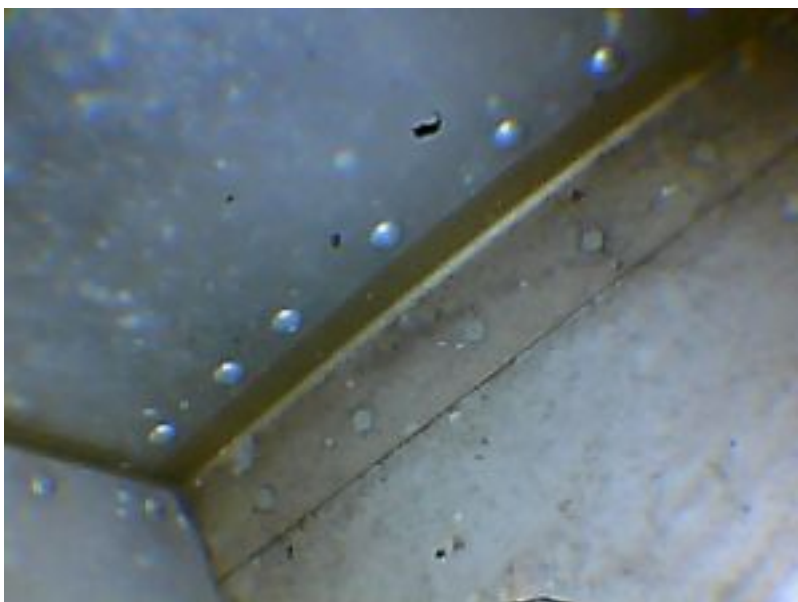
Just a little something growing here...

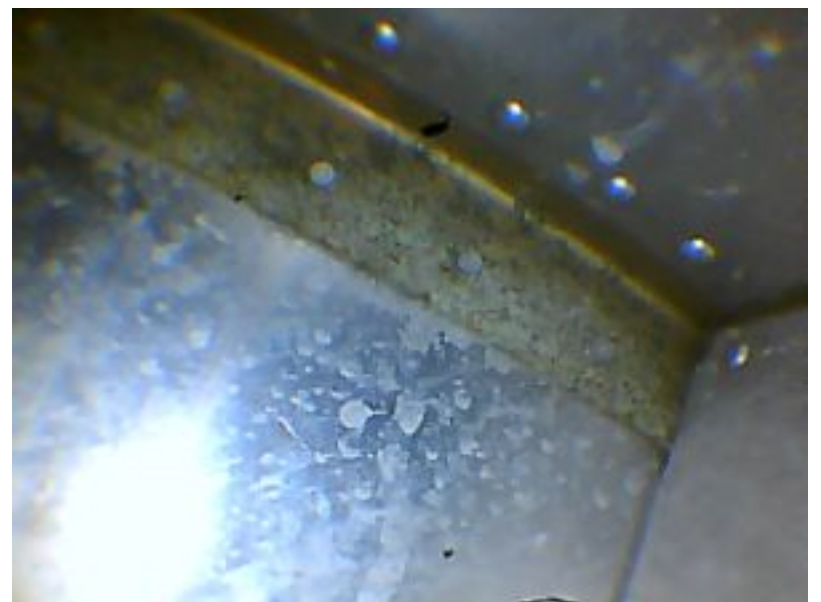
would be good to corrosion proof it to stop this.
