Inspection of N20313

for Ron Snider
Crescent City CA Airport (CEC)
Date Inspected: 6/8/19

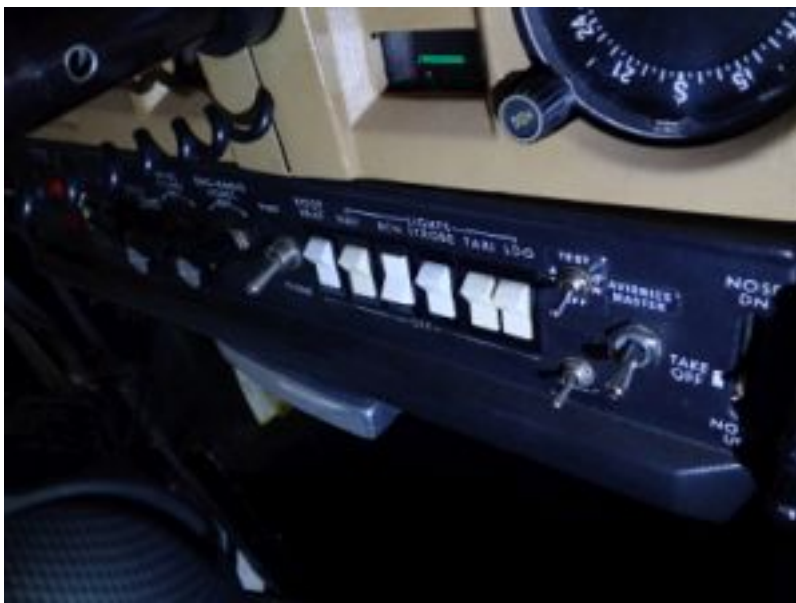
Interesting switches on the panel, one unlabelled.

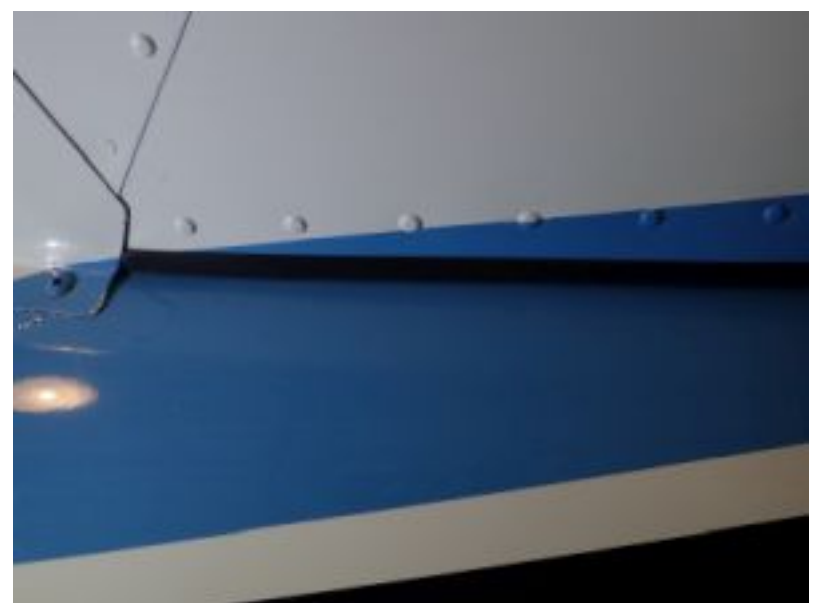
The rubber edge protector is on the rudder, very good extra credit!

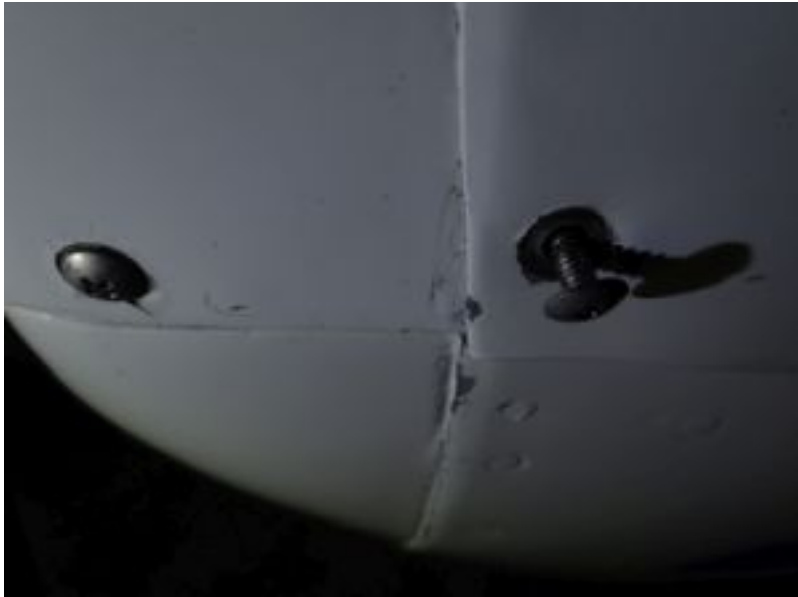
Machine screw where most have a sheet metal screw, but the proper receiver was installed so it is OK.

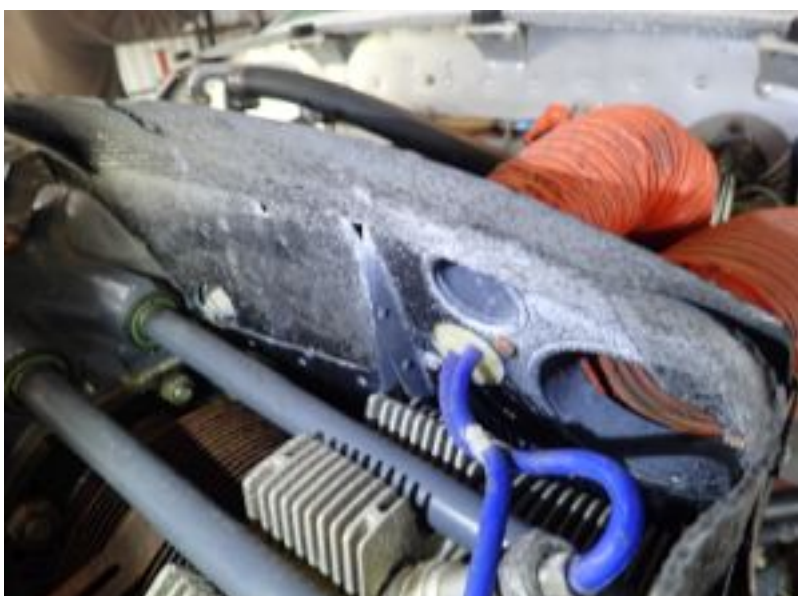
General overview.. seems like some salt collecting here, a good rinse would be a good idea once you get it home.
