CESSNA AIRCRAFT COMPANY

Weight & Balance and Installed Equipment Data

CONTROL NUMBER	DATE	MODEL	REGISTRATION NUMBER	CESSNA SERIAL NUMBER
920011	06/29/78	SKYLANE RG 11	1407JK	K182J0010

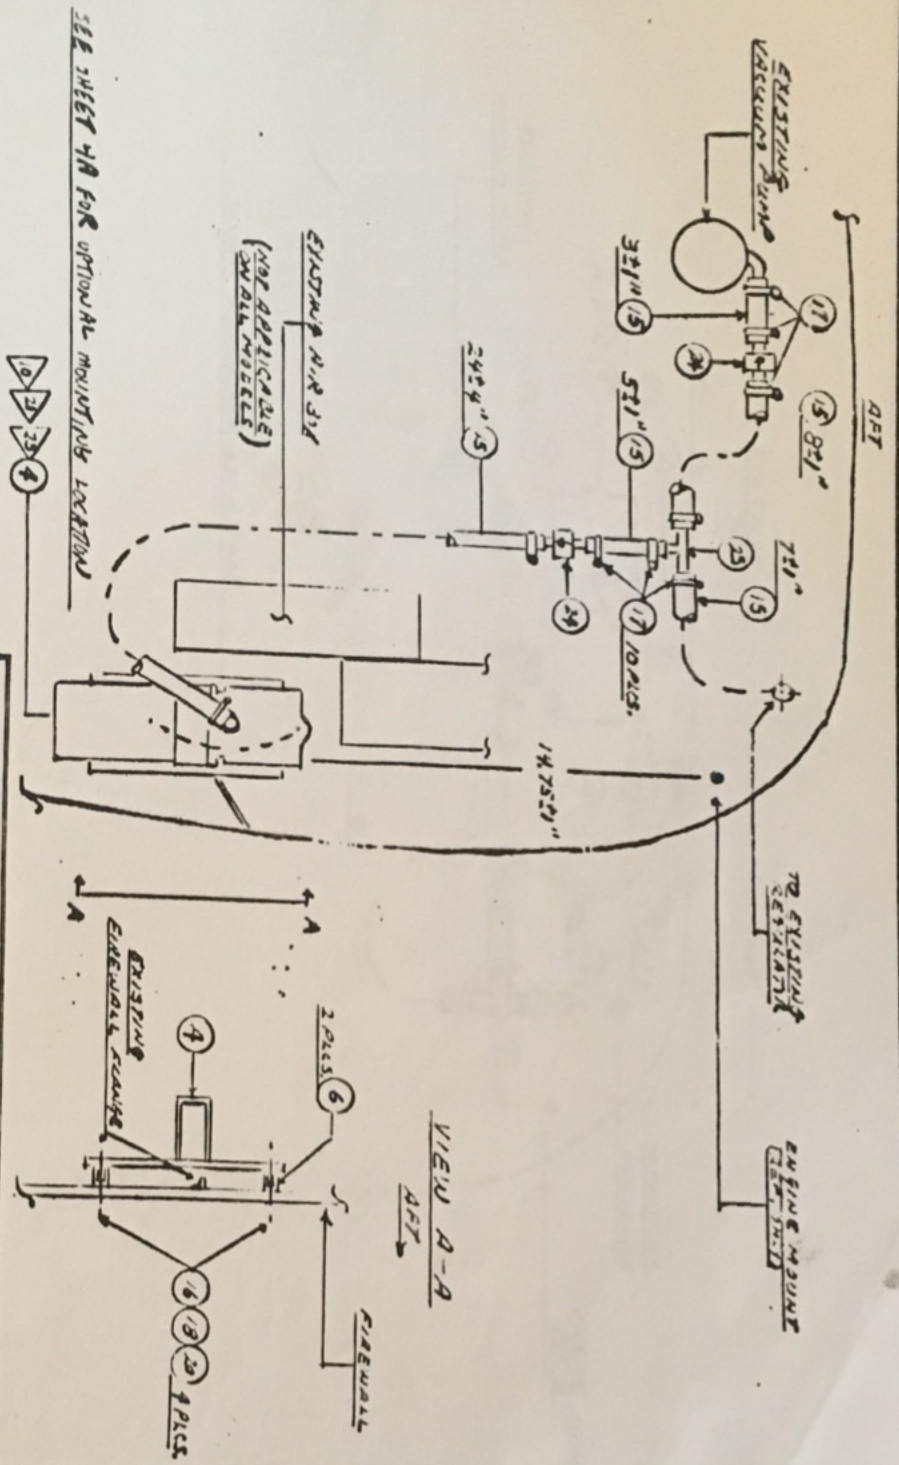
SCALE: NONE		APPROVED BY:	
DATED: 8-25-83		DRAWN BY: D. STAFFY	
VACUUM SYSTEM INSTALLATION		REVISED:	
AERO SAFE		SHEET # 29	
DRAWING NUMBER: 920 P-9			
CHANGE			
A

SEE SHEET 4A FOR OPTIONAL MOUNTING LOCATION

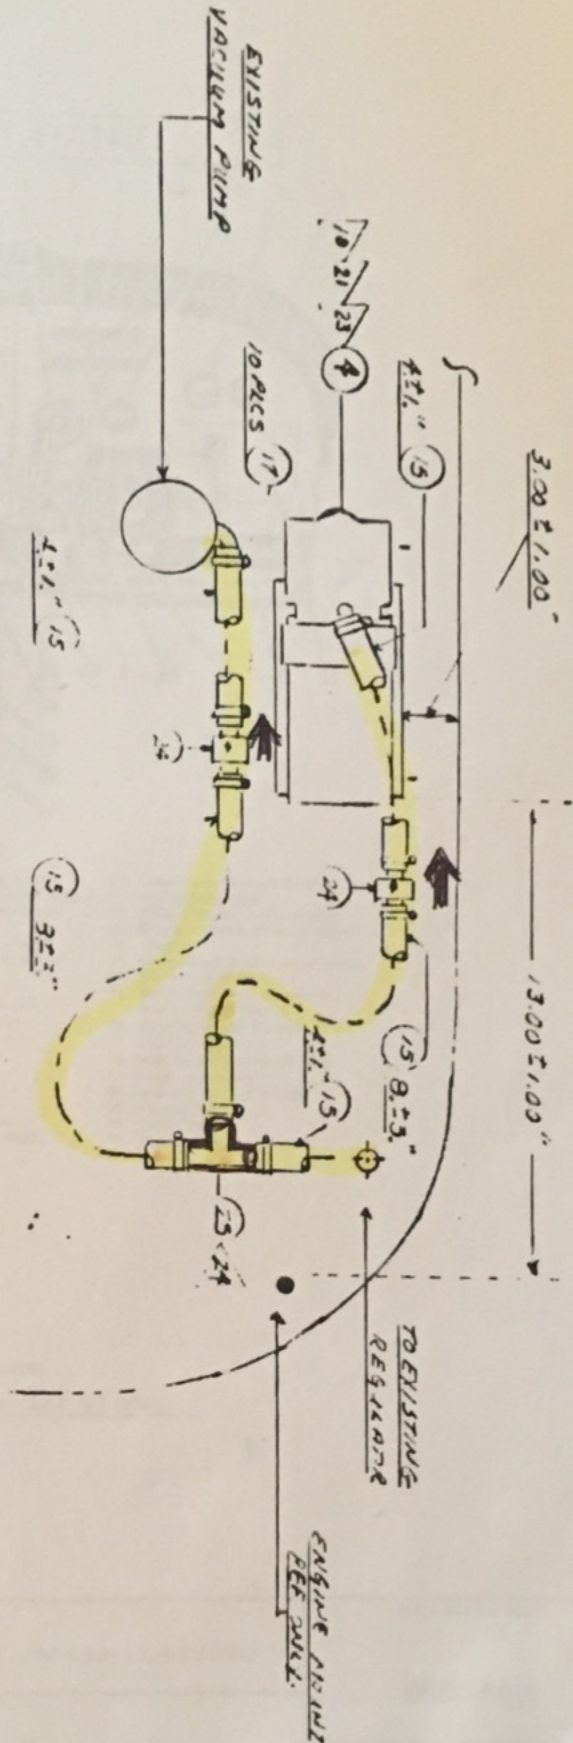
DRAWING NUMBER
 820004

OPTIMAL MIXING LOCATION

FIREWALL - LOOKING AFT	
SCALE: None	APPROVED BY:
DATE: 8-30-93	DRAWN BY: D. SUREFLY
	REVISED
