Inspection of N20313

for Ron Snider
Crescent City CA Airport (CEC)
Date Inspected: 6/8/19

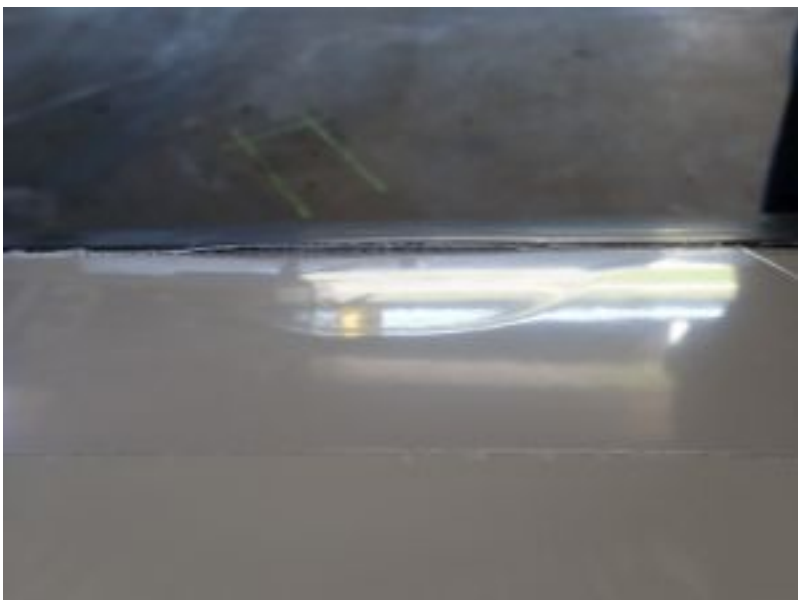
Prior repairs of filiform.

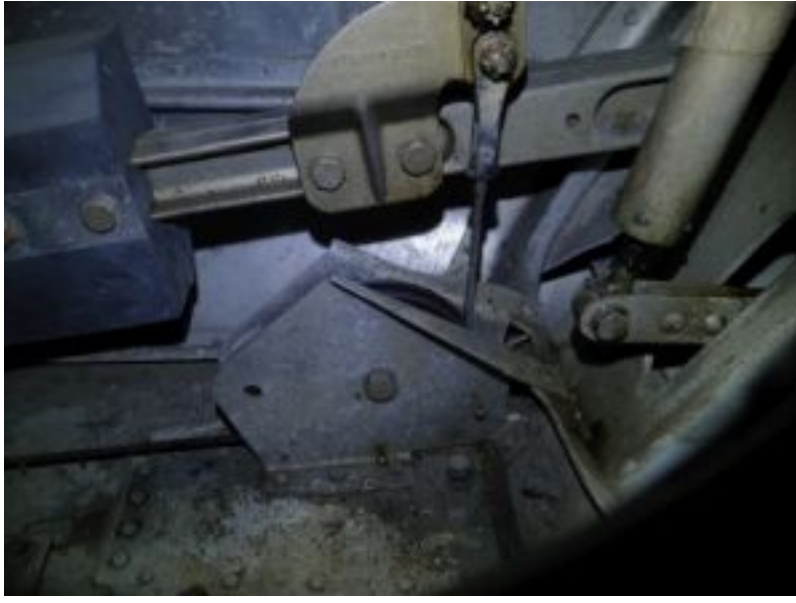
Pulley brackets were green, unusual.

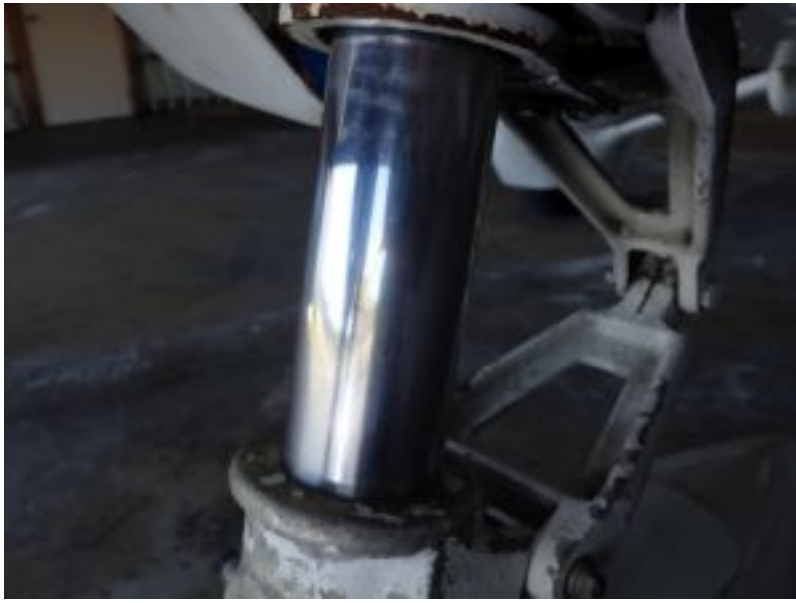
No chips on the strut.

Very slight wrinkles by door hinge.

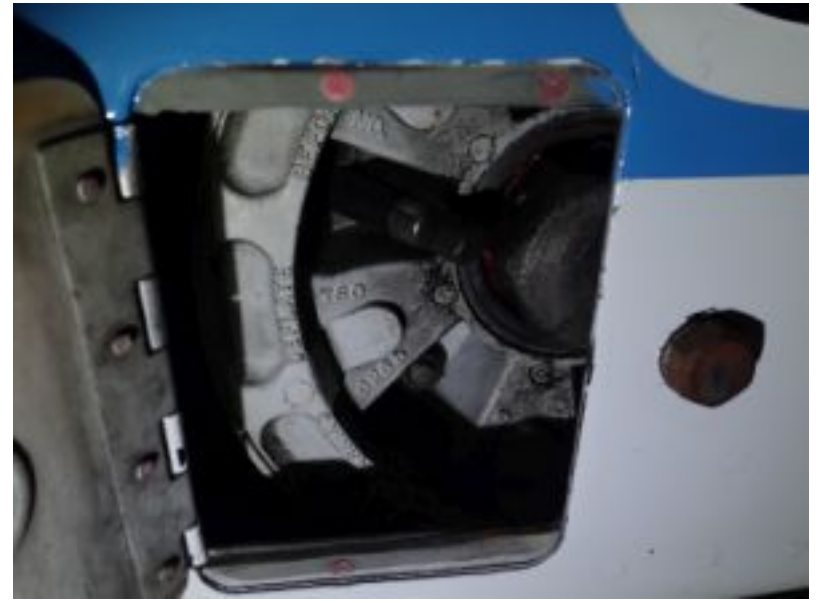
2 piece wheels is good news!

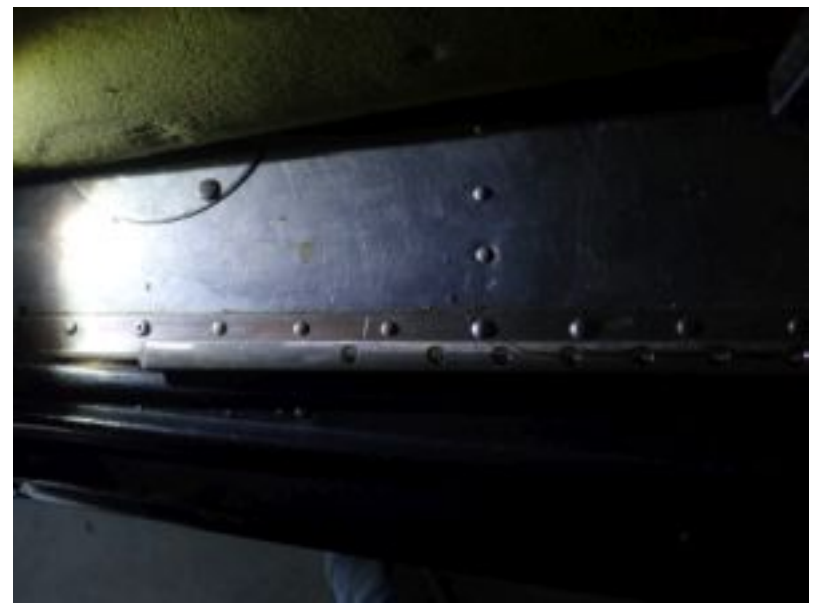
An odd assortment of rivets but they seem to be solid.

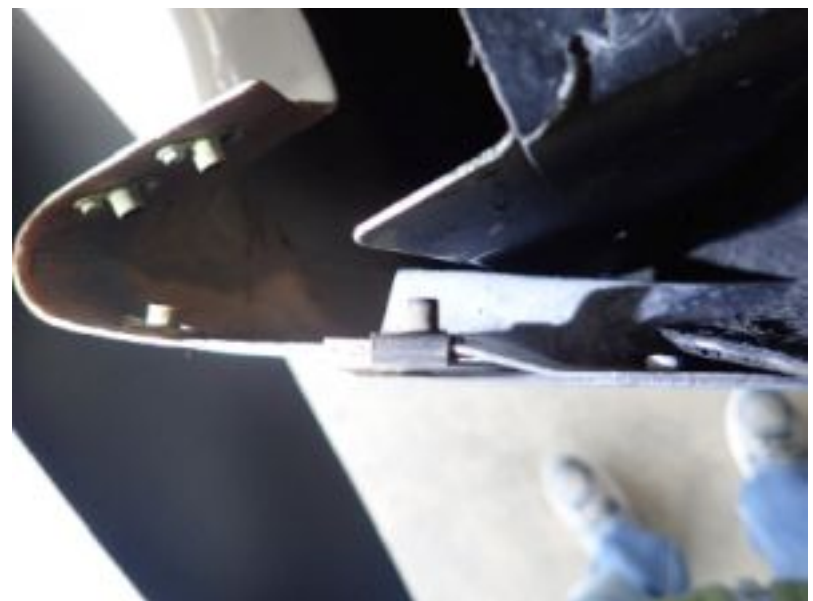
Here's that machine screw receiver mentioned above.

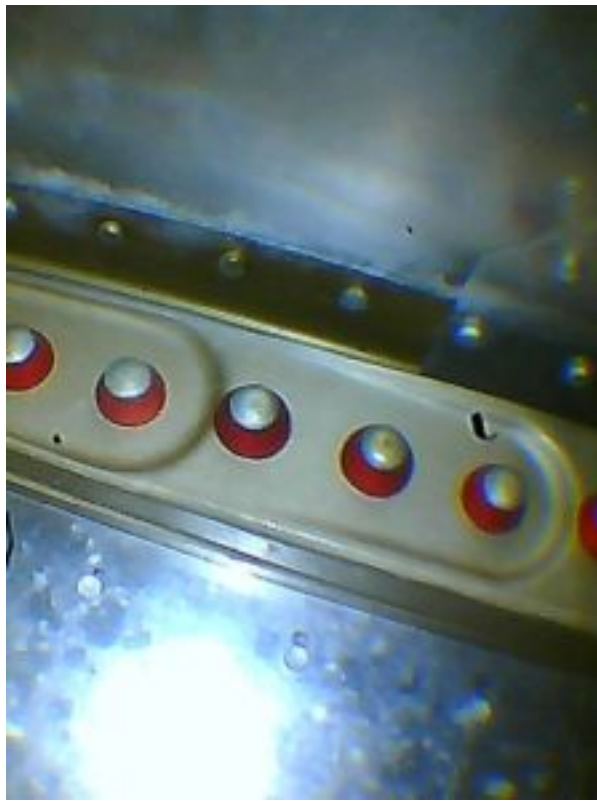
Stab brackets are good.

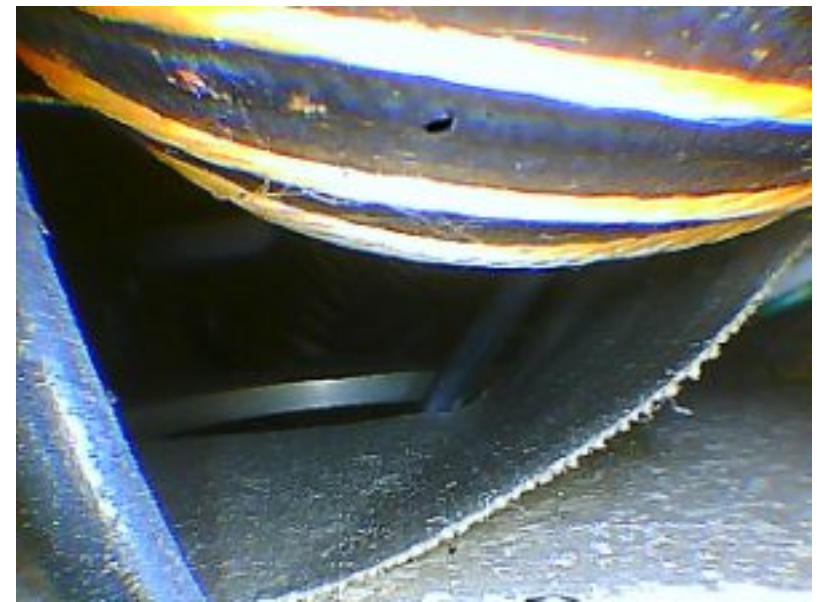
Limited contact between CAT and spar.
